RECOVERY OF THE ACCESS TO JORBA'S CASTLE: AS IF NOTHING HAD BEEN DONE

Posted on June 12, 2019 by editorship

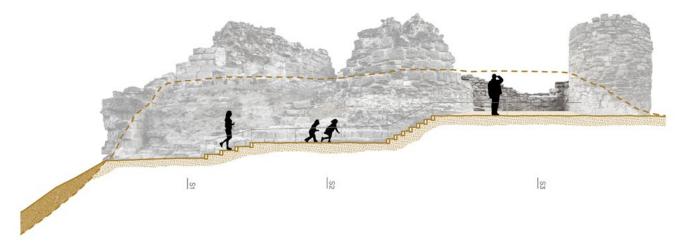
LONGITUDINAL SECTION

Due to difficulties in accessing the top of the hill, the works have been carried out entirely by manual means using materials that were easy to handle and transport. A minimal intervention was proposed, understanding that the pre-existences of the castle and the landscape are the heart of the design. The new staircase consists of 20x12 cm wooden slats in two different widths (1.20 and 0.60 meters), optimizing the original pieces without generating waste. The access limits are indicated by a rope at 60cm in height, which indicates the route and the areas that can be visited, held by eight corrugated rods of 12mm in diameter.

An ascending step of 12 meters is proposed across five sections of two different widths, adapting to the pre-existing conditions and following the structures that mark the castle's limits. An old existing path is used as a route for the first two sections of the new access. The third section is perpendicular to the walls of the castle and offers a view of its north elevation. The last two sections run tangent to the main guideline of the walls and allow for direct contact with the archaeological remains. Once you reach the upper level, you get a view of the village of Jorba and the old royal road.
