## RECOVERY OF THE ACCESS TO JORBA'S CASTLE: AS IF NOTHING HAD BEEN DONE

*Posted on June 12, 2019 by editorship*

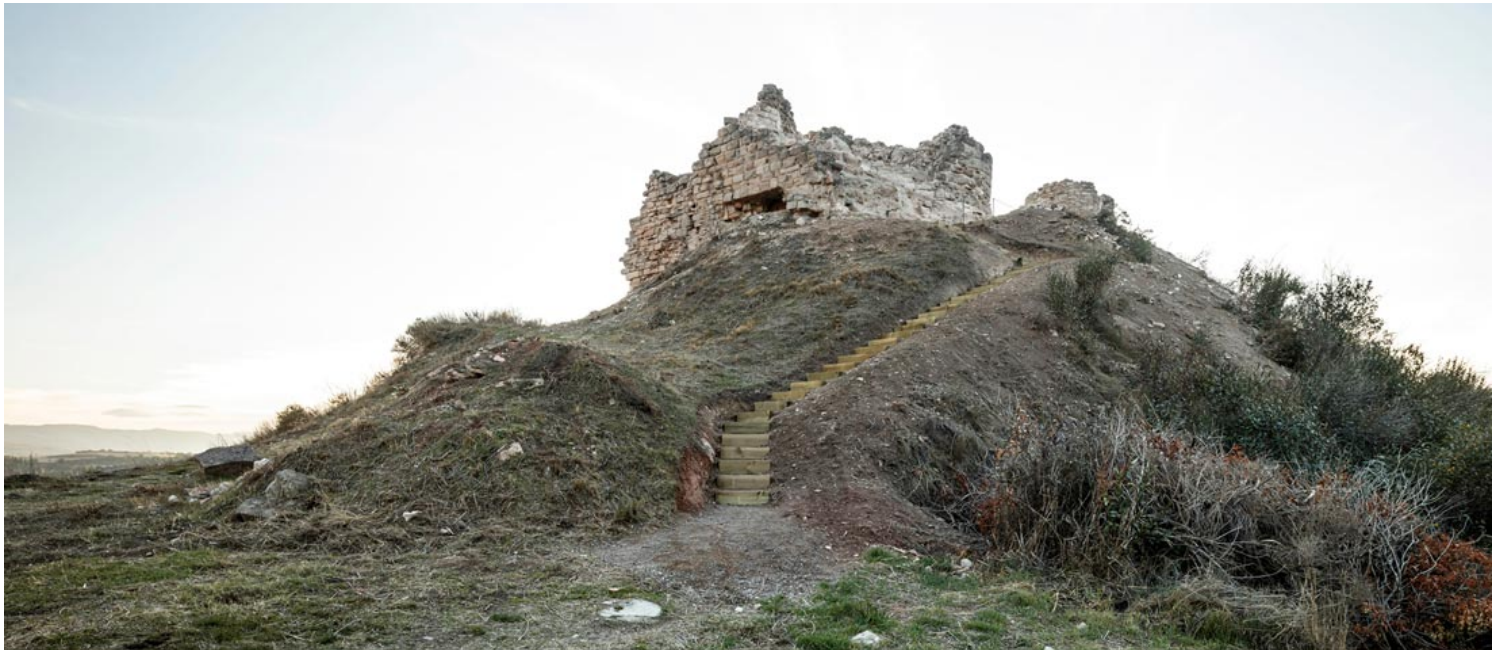
The purpose of the intervention is to provide access to the watchtower, where the relationship with the town and the territory is recovered, highlighting the original lookout function that motivated its construction. The project is carried out using the material removed during the archaeological excavation, which is reused in order to build a new topography. The 300 m<sup>3</sup> of extracted soil volume

is used entirely to generate a sequence of platforms that expands the route to the lookout, making it more secure.

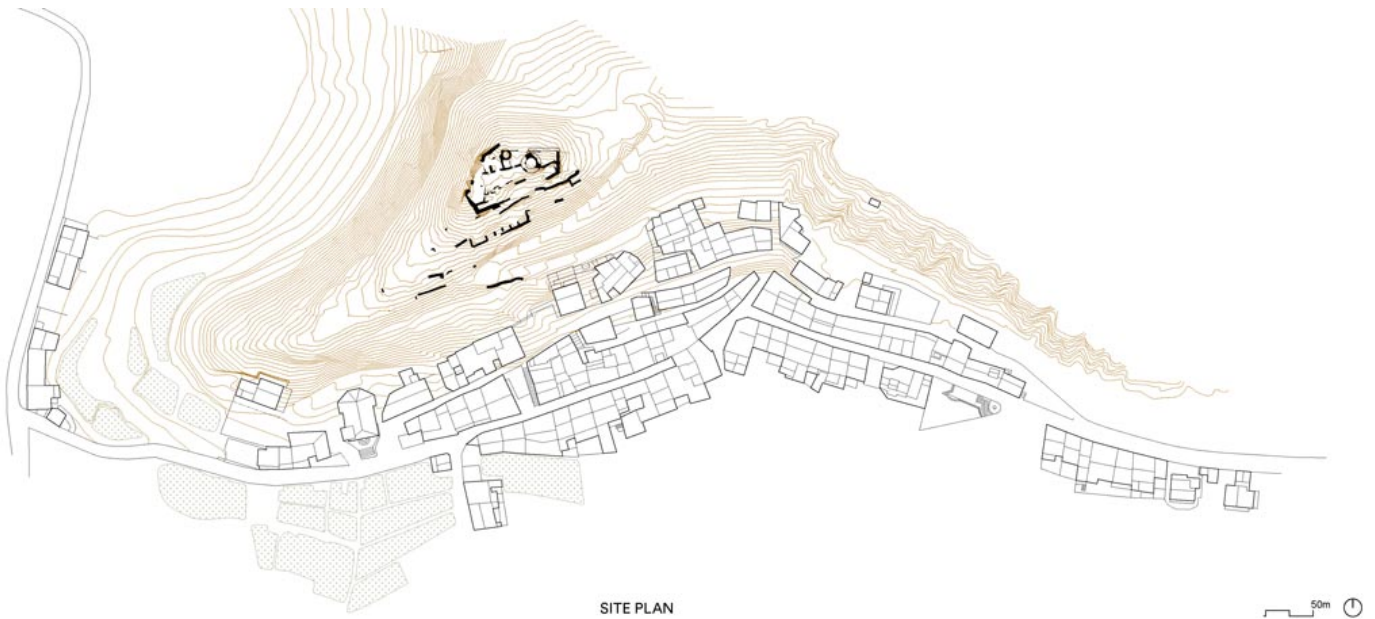
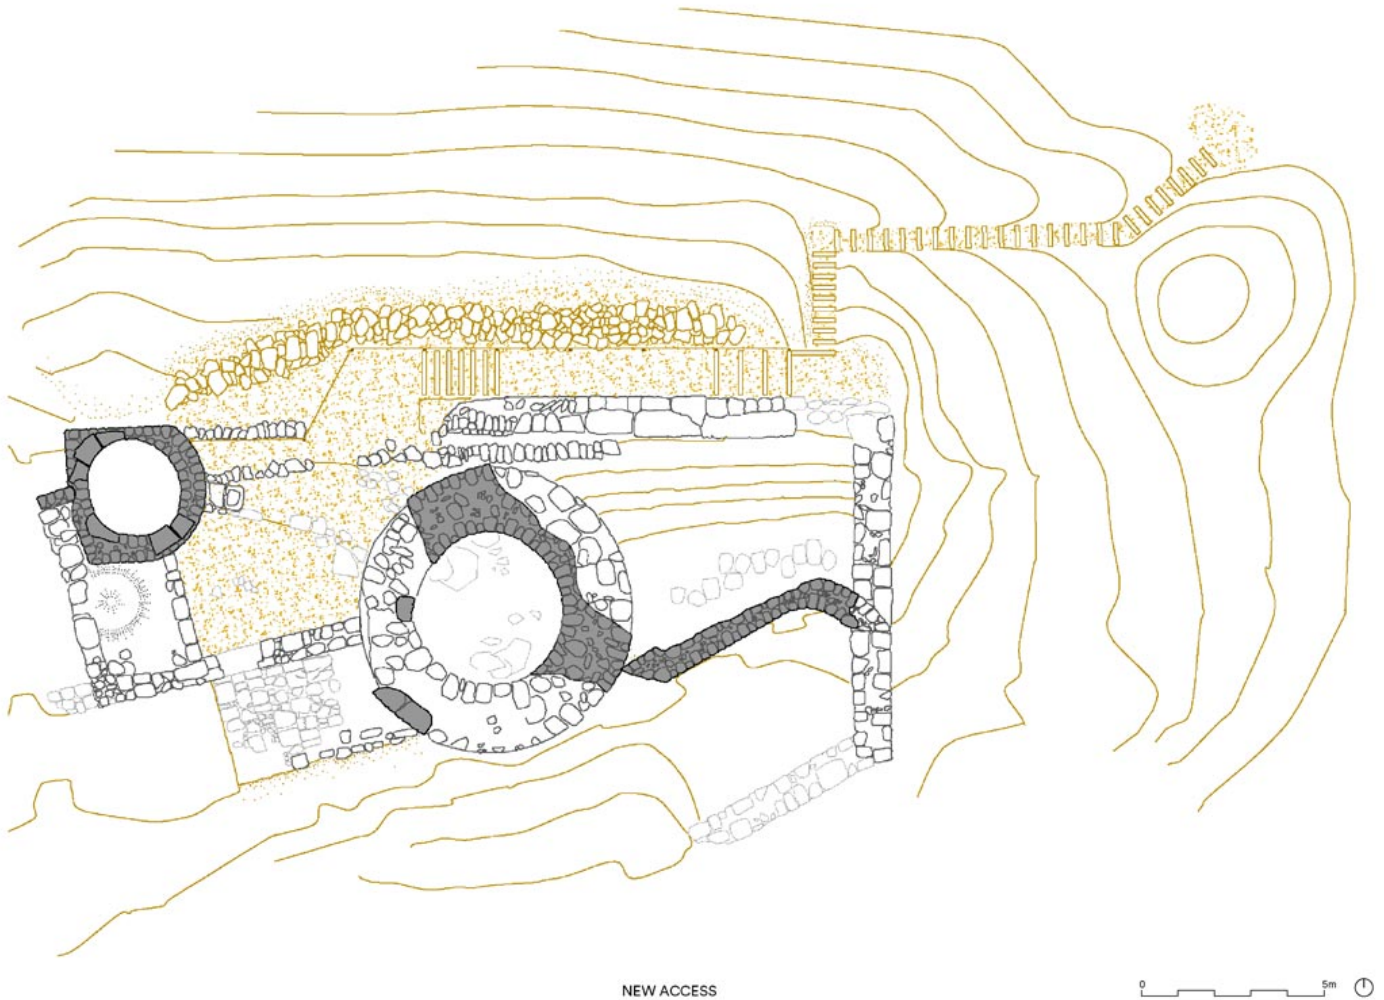
An ascending step of 12 meters is proposed across five sections of two different widths, adapting to the pre-existing conditions and following the structures that mark the castle's limits. An old existing path is used as a route for the first two sections of the new access. The third section is perpendicular to the walls of the castle and offers a view of its north elevation. The last two sections run tangent to the main guideline of the walls and allow for direct contact with the archaeological remains. Once you reach the upper level, you get a view of the village of Jorba and the old royal road.

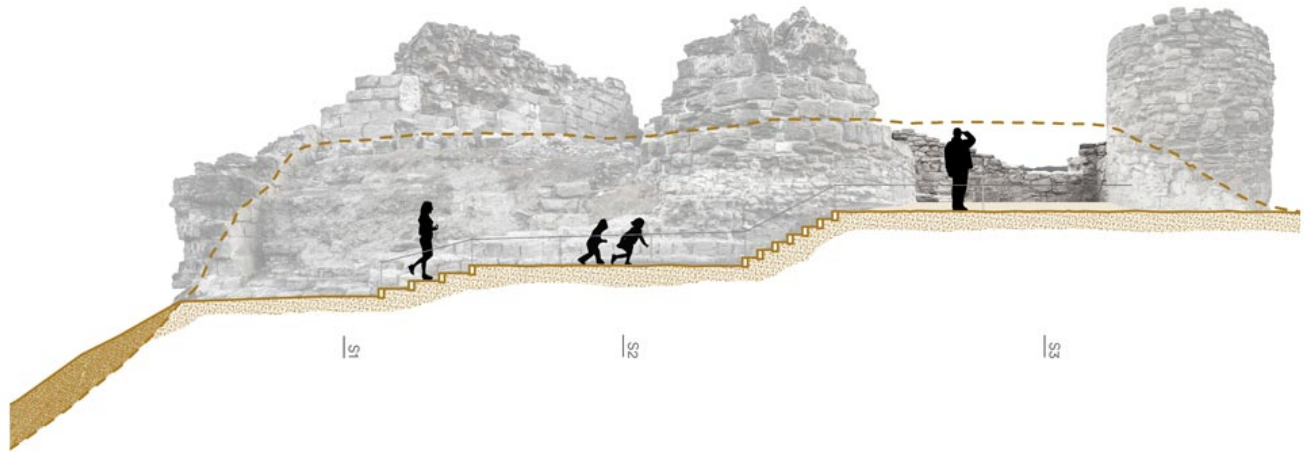
LONGITUDINAL SECTION

Due to difficulties in accessing the top of the hill, the works have been carried out entirely by manual means using materials that were easy to handle and transport. A minimal intervention was proposed, understanding that the pre-existences of the castle and the landscape are the heart of the design. The new staircase consists of 20x12 cm wooden slats in two different widths (1.20 and 0.60 meters), optimizing the original pieces without generating waste. The access limits are indicated by a rope at 60cm in height, which indicates the route and the areas that can be visited, held by eight corrugated rods of 12mm in diameter.

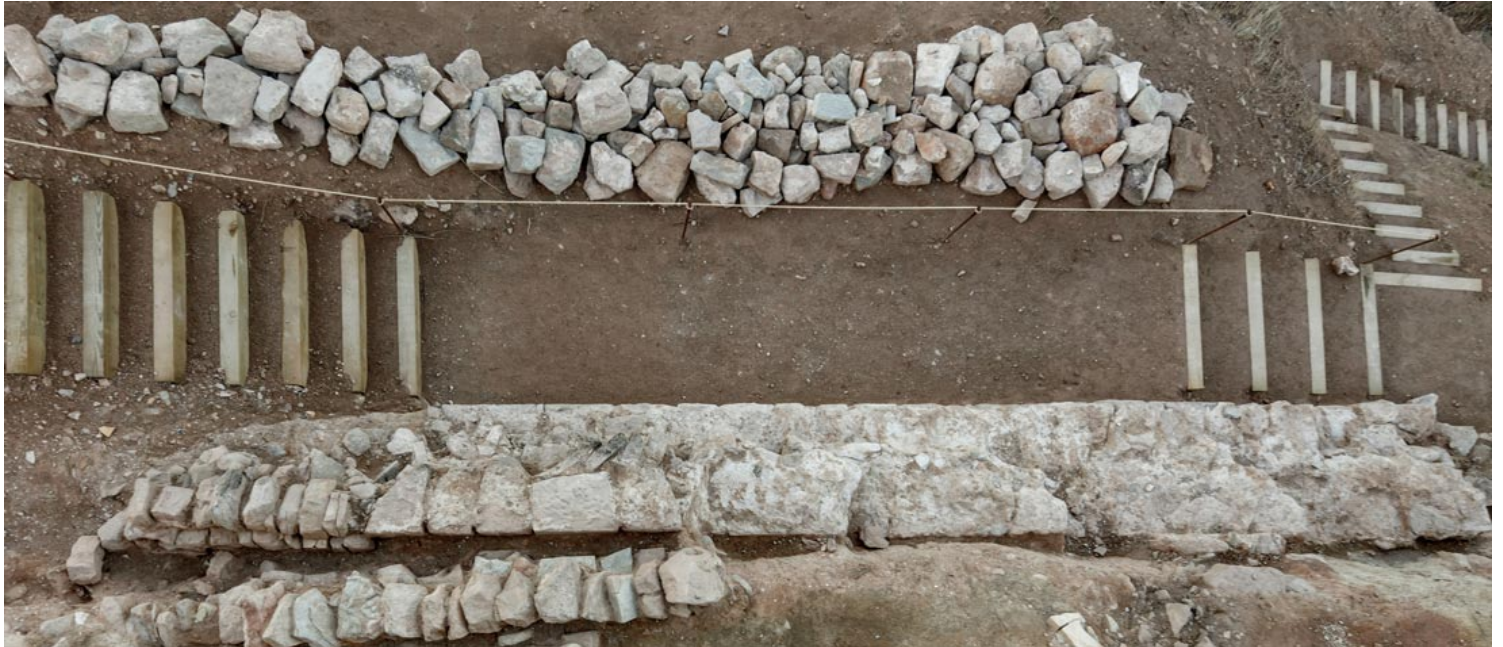
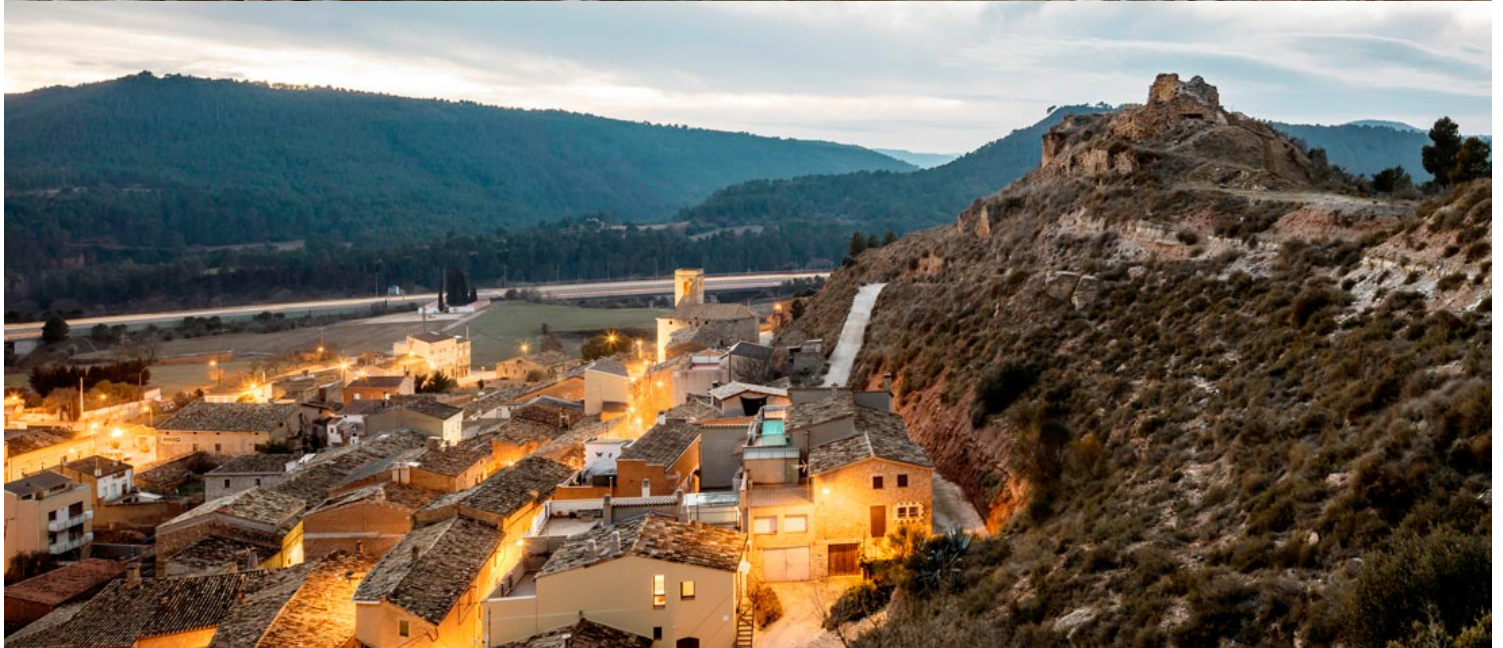
consolidated, reusing stones found during the excavations, allowing for the recovery of part of the castle's extension, walls from the initial phases of construction, as well as the circulation levels of the battlement. The stones recovered during the excavation that were not used in consolidating the most damaged structures have been collected next to the path, waiting to be reused in later phases.
