## LA REMUNTA: CONSOLIDATION OF BARRACK BUILDINGS

The project involved the restoration of part of the former army barracks, dedicated to horse breeding, at La Remunta in Hospitalet de Llobregat, Barcelona. In agreement with the City Council, part of the enclosure has been converted to a public park and sites earmarked for the development of housing blocks. All remaining buildings on the site are protected.

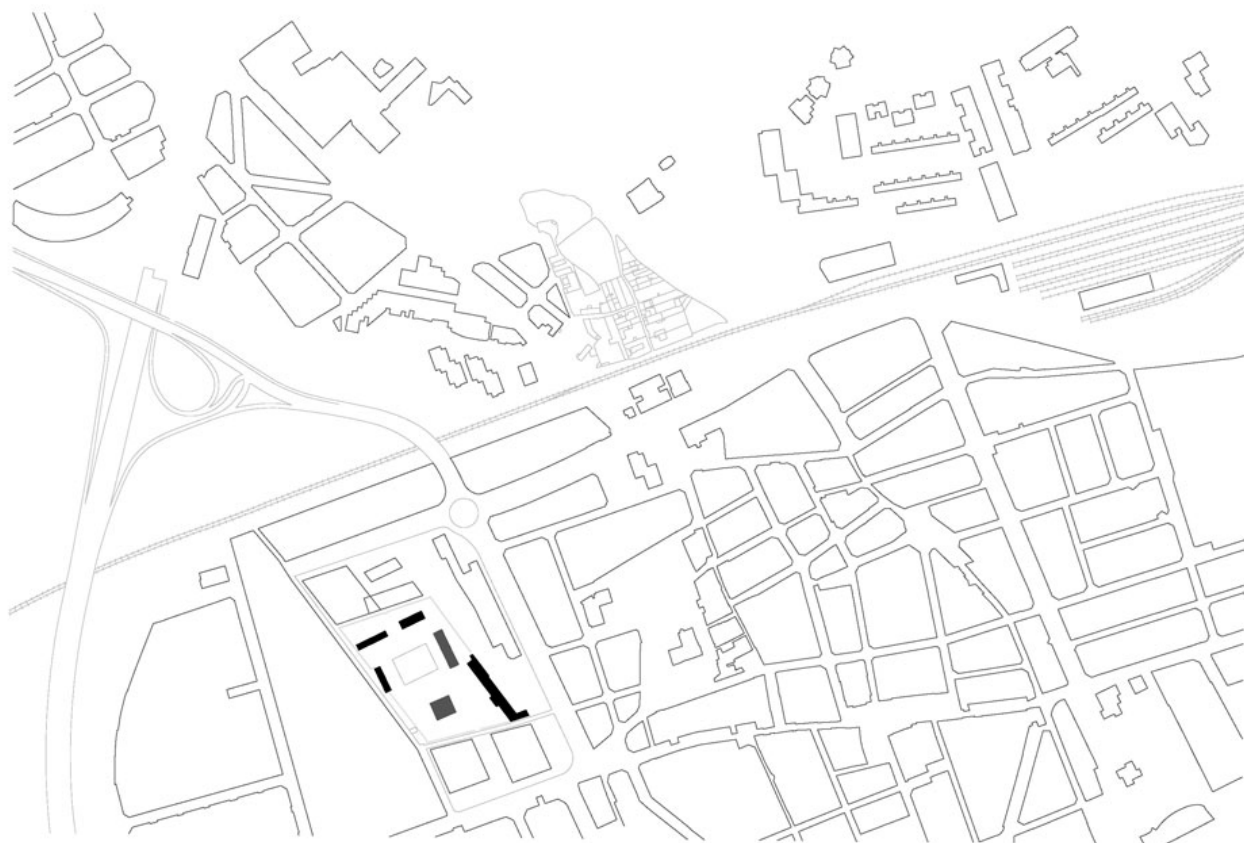
The consolidation and rehabilitation of the existing structural elements was the main guideline for the project, in addition to the preservation of the most characteristic elements of its initial function of breeding horses. It also took into account maintaining the elements in good condition to ensure they would be compatible with common uses.

Underpinning foundations have been avoided, and perimeter walls have been introduced to strengthen the highest parts.

As for the façades, the aim of the project was to restore the original finish, a plastering lime mortar
