LA REMUNTA: CONSOLIDATION OF BARRACK BUILDINGS

The project involved the restoration of part of the former army barracks, dedicated to horse breeding, at La Remunta in Hospitalet de Llobregat, Barcelona. In agreement with the City Council, part of the enclosure has been converted to a public park and sites earmarked for the development of housing blocks. All remaining buildings on the site are protected.

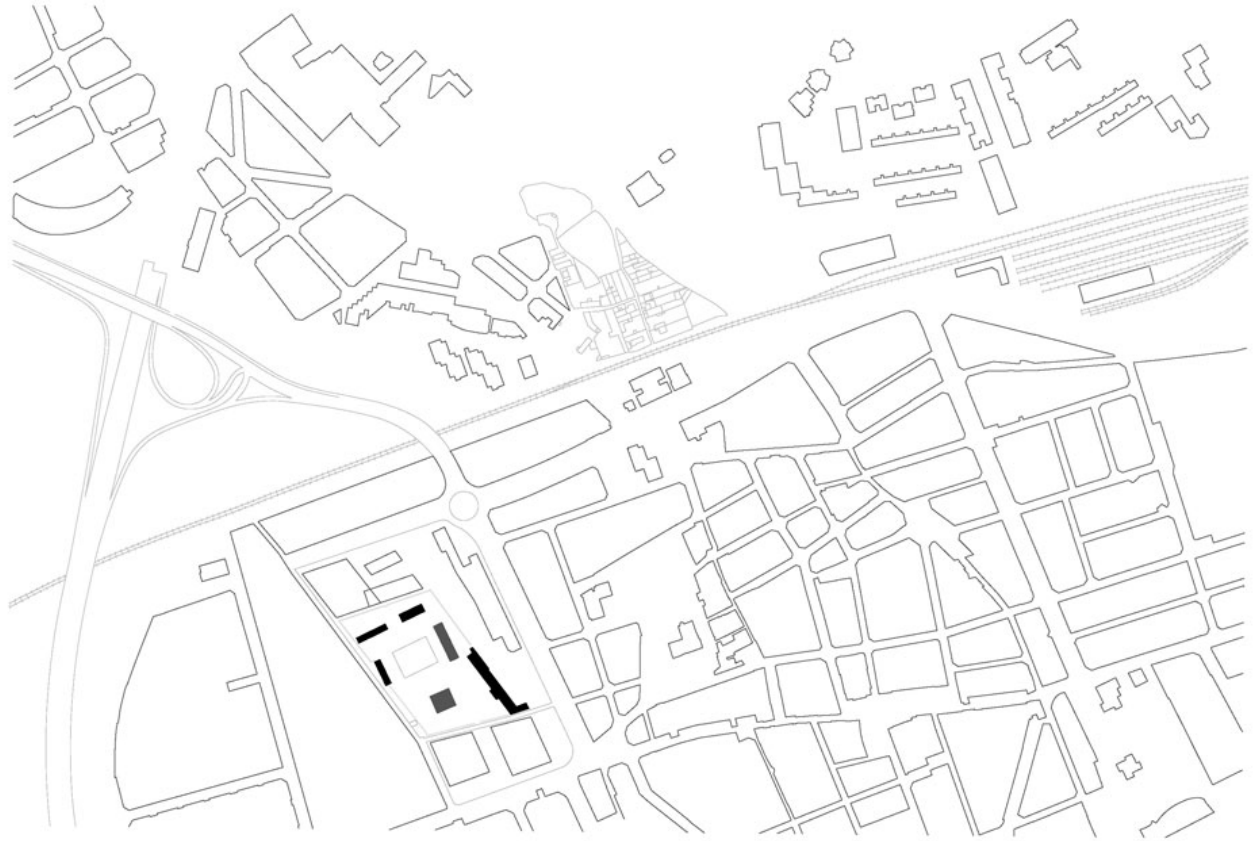
The consolidation and rehabilitation of the existing structural elements was the main guideline for the project, in addition to the preservation of the most characteristic elements of its initial function of breeding horses. It also took into account maintaining the elements in good condition to ensure they would be compatible with common uses.

Underpinning foundations have been avoided, and perimeter walls have been introduced to strengthen the highest parts.
