LA REMUNTA: CONSOLIDATION OF BARRACK BUILDINGS

The project involved the restoration of part of the former army barracks, dedicated to horse breeding, at La Remunta in Hospitalet de Llobregat, Barcelona. In agreement with the City Council, part of the enclosure has been converted to a public park and sites earmarked for the development of housing blocks. All remaining buildings on the site are protected.

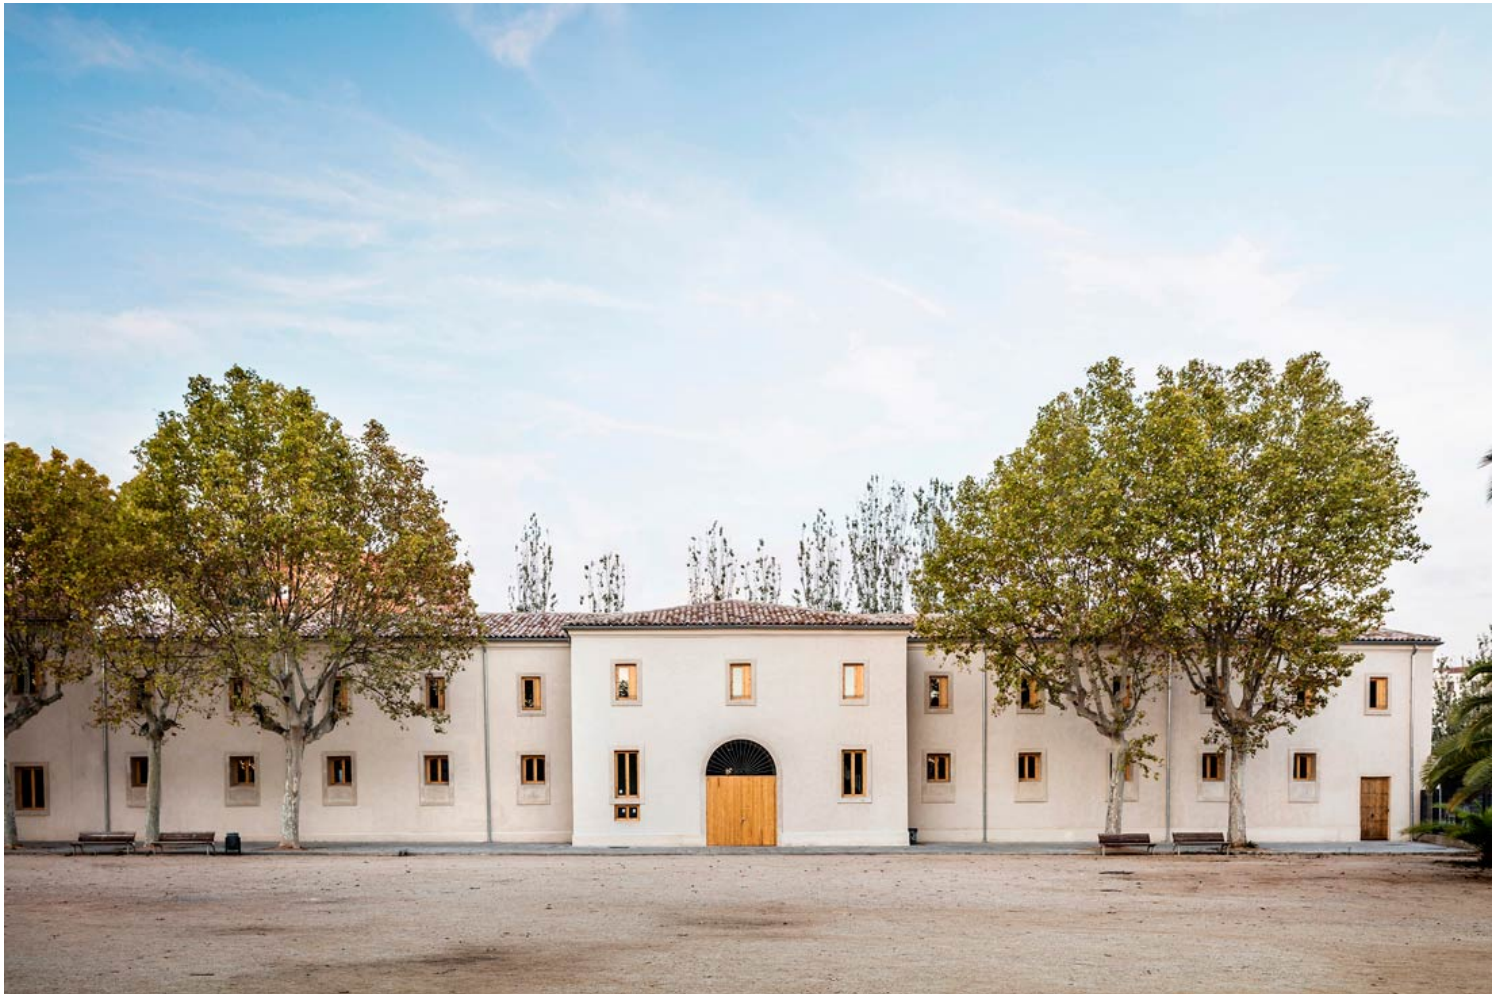
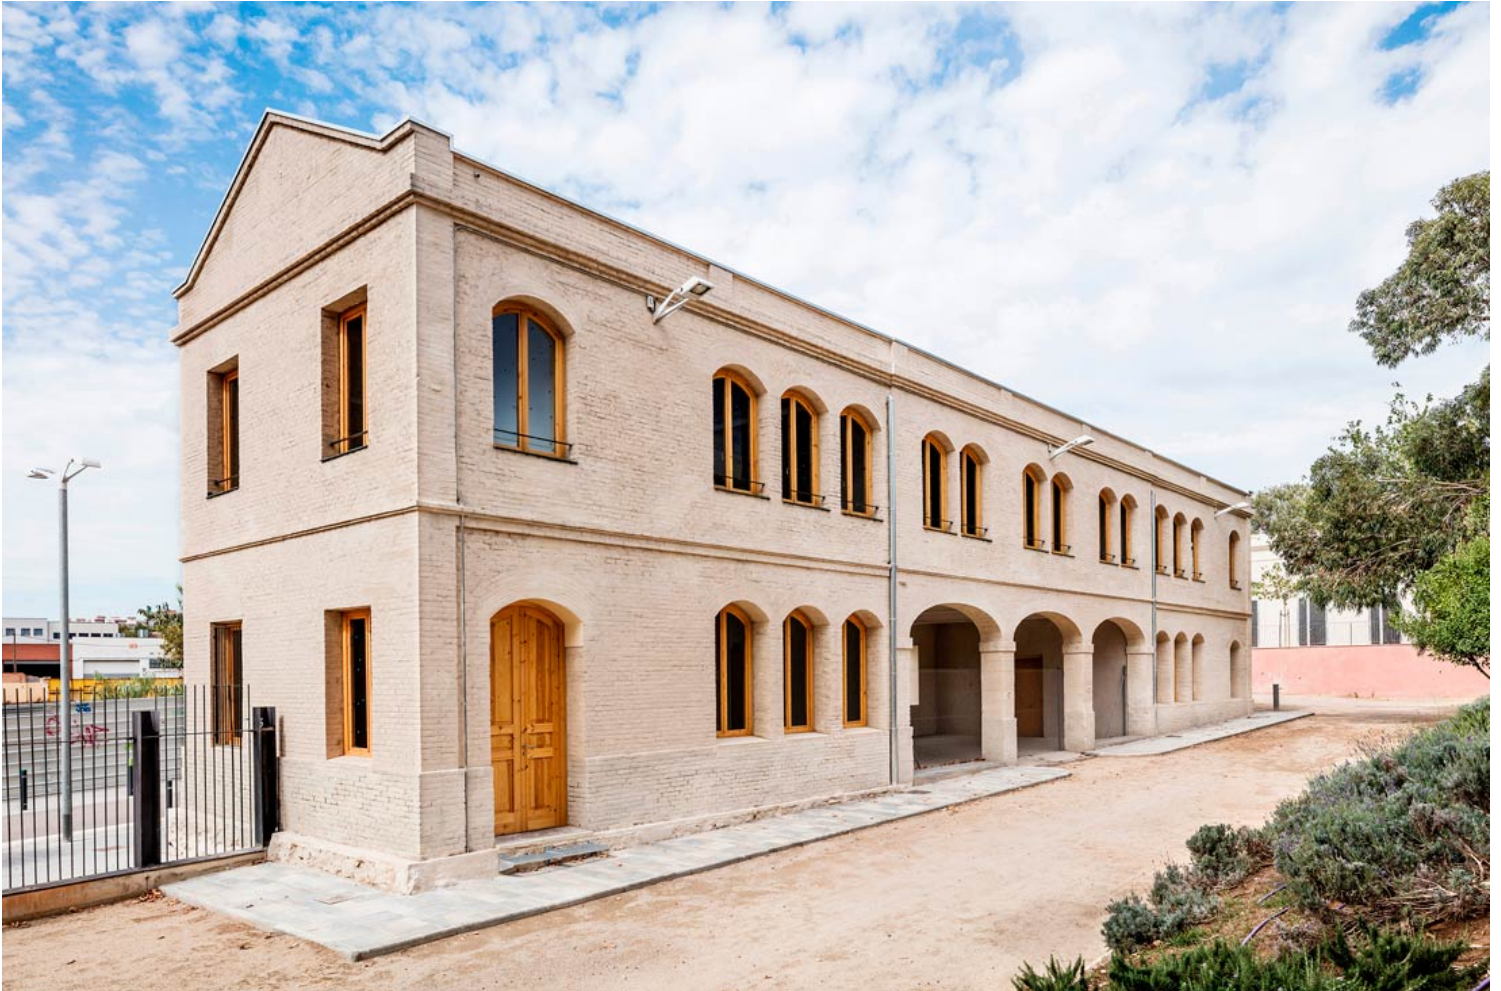
The old barracks consisted of six buildings, four of which were the subject of this project. Building 1 included stables and a soldier's mess hall on the ground floor, and a dormitory for soldiers and officers on the first floor. Buildings 3 and 4 are single-storey constructions, used only for horses. Building 5 was an infirmary and laboratory. The two other buildings that were not part of this project. The old farmhouse and Building 2 will be developed separately as a nursery school.

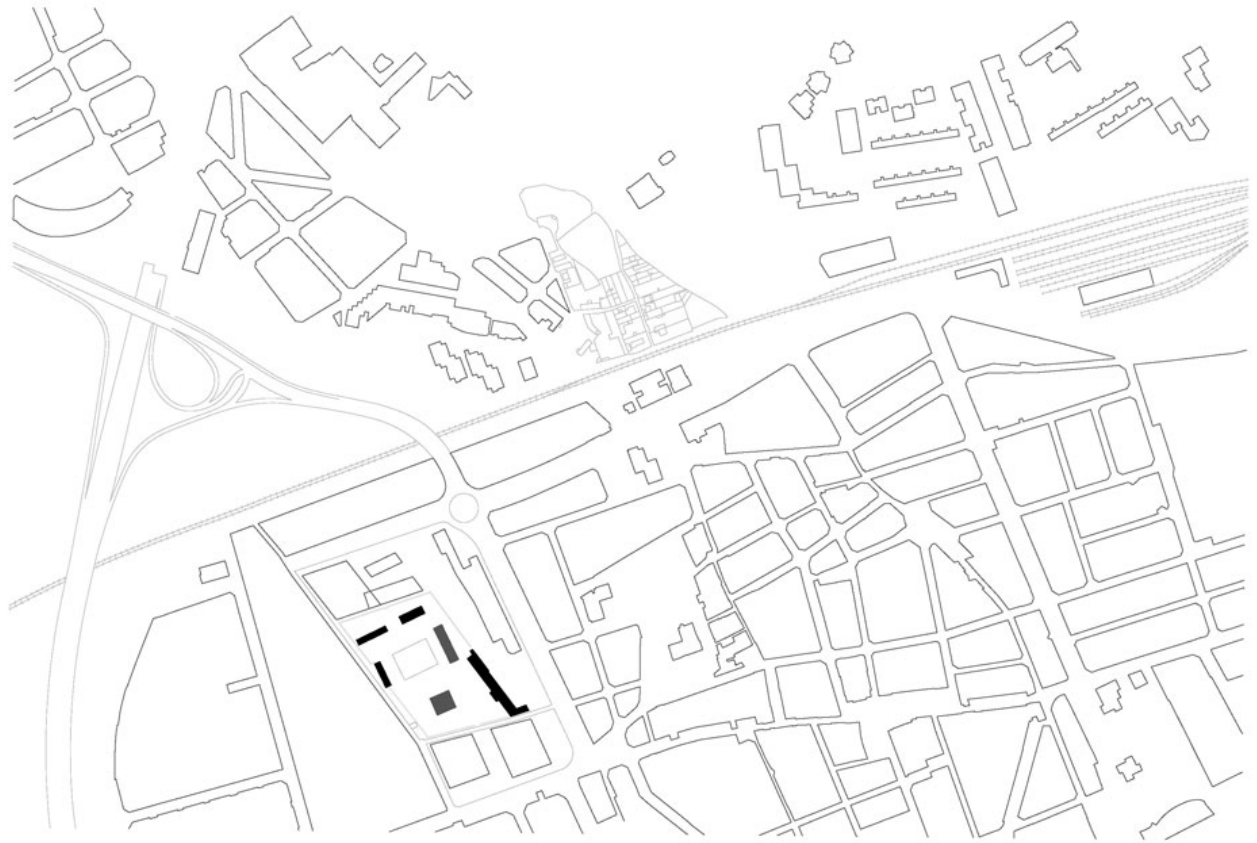
The consolidation and rehabilitation of the existing structural elements was the main guideline for the project, in addition to the preservation of the most characteristic elements of its initial function of breeding horses. It also took into account maintaining the elements in good condition to ensure they would be compatible with common uses.

Underpinning foundations have been avoided, and perimeter walls have been introduced to strengthen the highest parts.

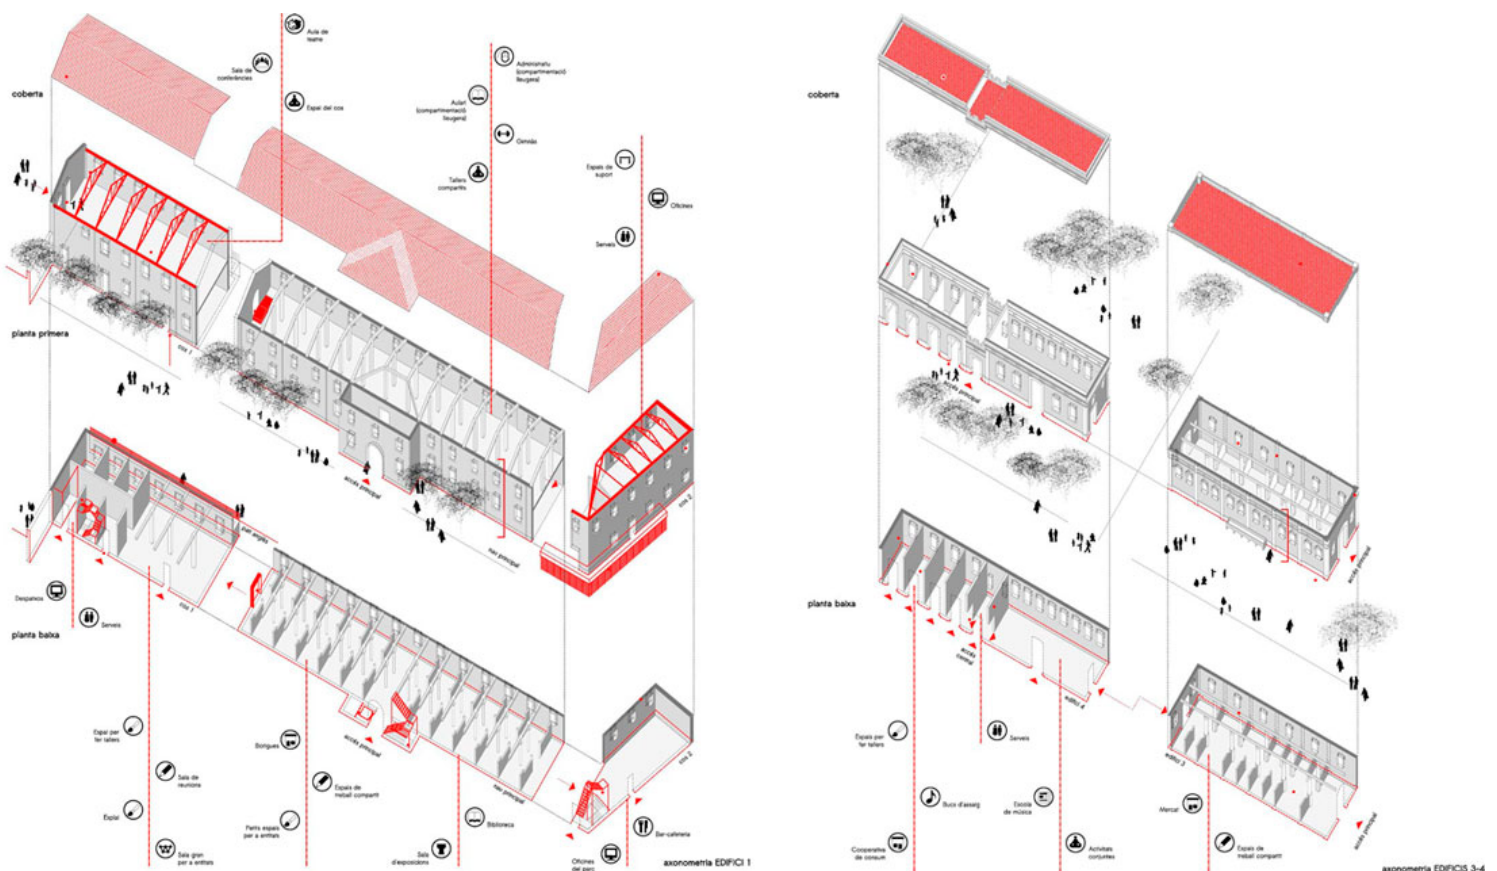
The roofs were fully rebuilt, maintaining the existing trusses and beams. Thermal insulation was added in some sections, using sandwich panels with wood shavings. Most of the existing tiles were recovered from the demolition, in order to keep the roof's original appearance. Inside the building, interior partitions and ceilings were demolished and finishes, tiles and superimposed banisters were removed.

The original floors were maintained, as well as some old troughs and animal feeders, as an explanation of the building's initial function. Side entrances and service access points were created in the blind side façades. A window was also built into the upper corner of the first floor to avoid the appearance of a blind façade.
