1111 LINCOLN ROAD: MUCH MORE THAN A CAR PARK

1111 Lincoln Road: Much More than a Car Park
<https://urbannext.net/1111-lincoln-road/>

The mixed use development called 1111 Lincoln Road in Miami Beach comprises four different parcels. An existing building, the former Suntrust building, is renewed since the bank has left the building to be accommodated around the corner. A mixed use structure for parking, retail and a private residence becomes attached to the Suntrust building. A two-story building with the relocated bank on the ground floor and four residences on the upper floor faces Alton Road, with a landscaped alley and surface parking lot behind it.

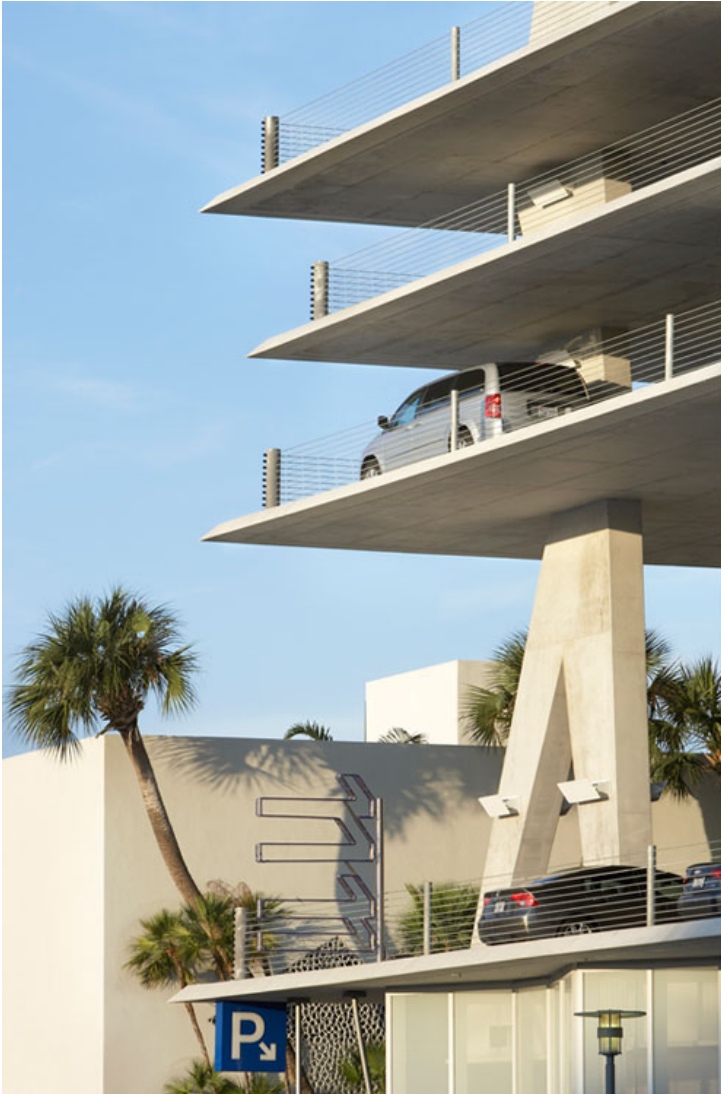
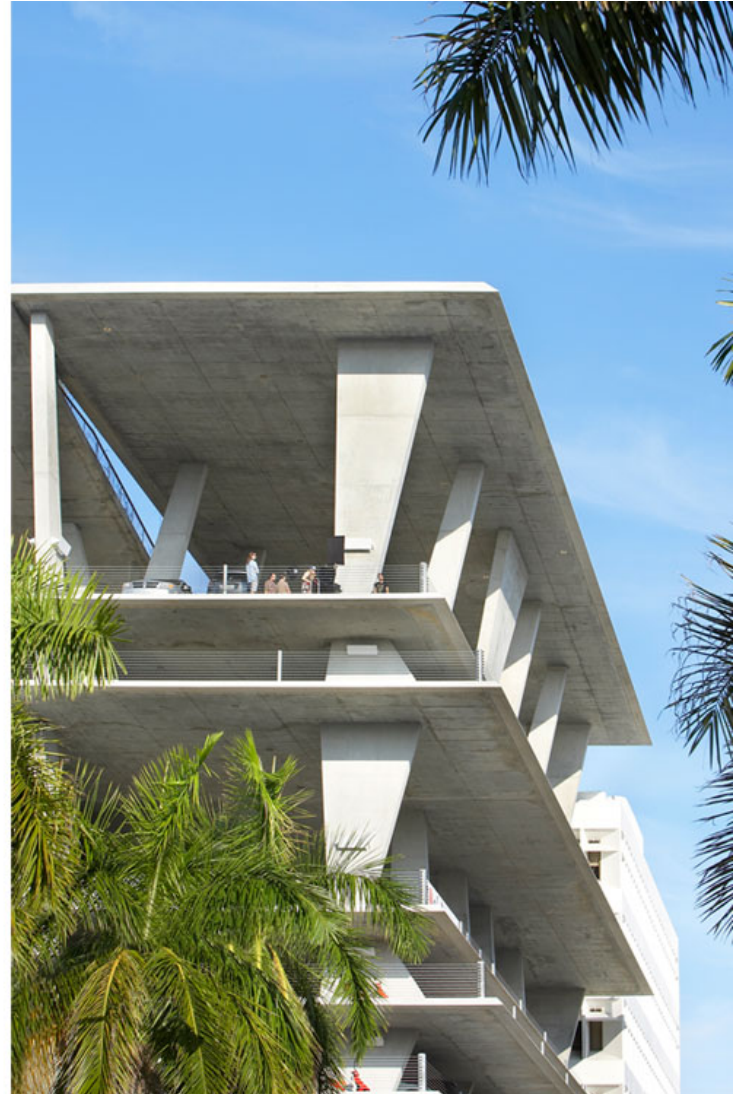
The structure is the architecture. The car park is an organism made up of a family of concrete slabs, deployed as floor plates, columns and ramps. The location and form of these elements result from a series of forces acting upon each other, a complex overlapping of site and building code requirements, combined with program choices and the aspiration to both integrate with Lincoln Road Mall and to formulate its beginning at the corner of Alton Road.

The nature of Lincoln Road was the one source of inspiration for the architecture of the car park, its being connected to the massive, closed Suntrust office building the other. The garage is a fully open concrete structure. Ceiling heights vary between standard parking height and double or even triple height, in order to accommodate other programs, permanently as well as temporarily. A retail unit and a private residence are located on the upper levels, and the structure can be used for parties, photo or film shoots, fashion shows, concerts or other social or commercial activities, offering amazing views as the backdrop for the stage. An unenclosed, sculptural stair in the centre of the building makes pedestrian circulation in the garage a panoramic, ceremonial experience, as is moving through the building in a car. The private residence that is nested on a mezzanine of the top floor of the car park spills out to terraces; it is folded into the structure yet screened by excessive landscaping. The terraces also bridge across to the roof of the existing building.

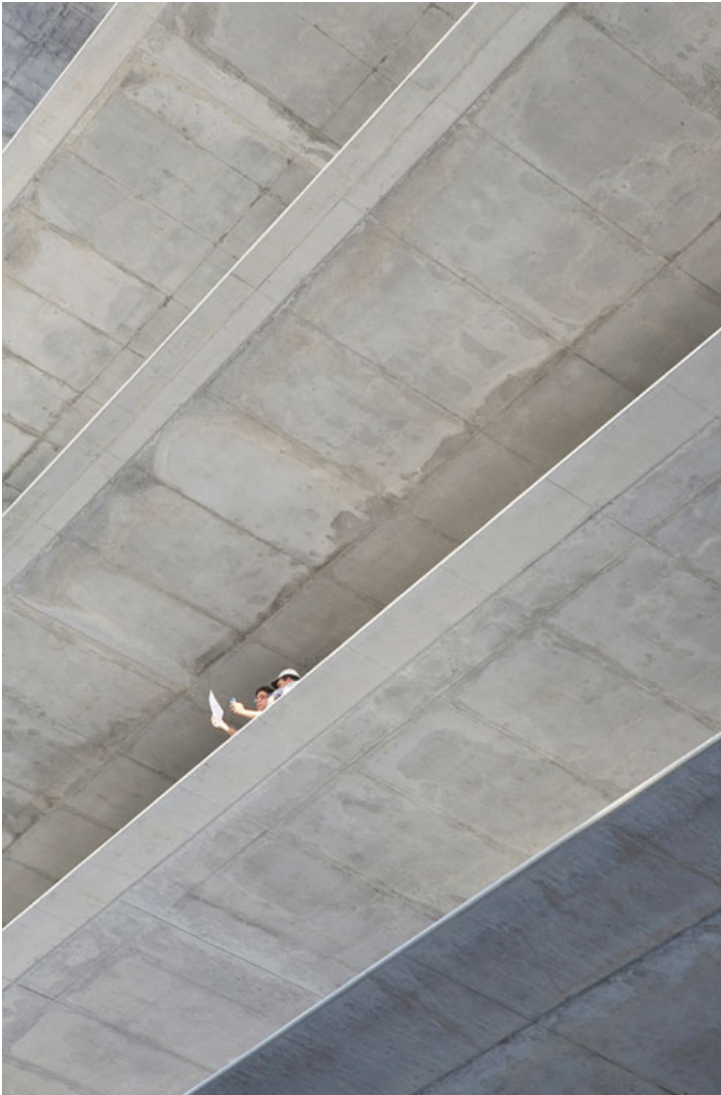
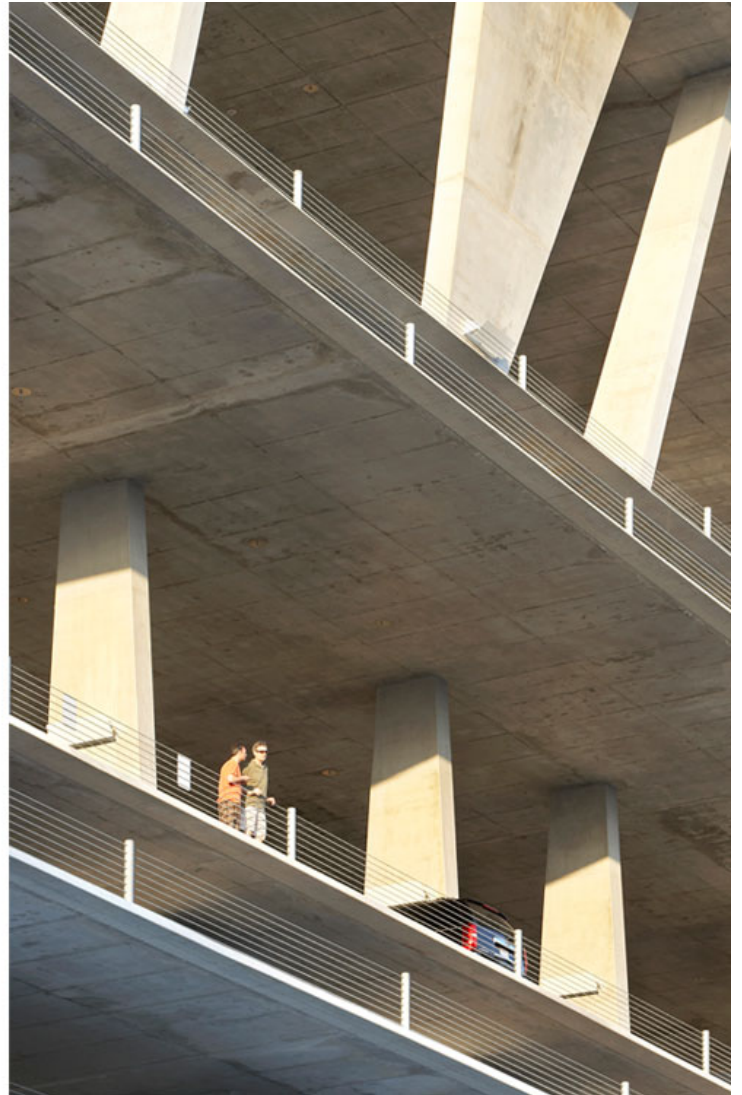
1111 includes the transformation of the massive Suntrust Bank building from the 1970s into a publicly accessible place. The lowest floor plate of the car park cuts away a large part of the ground floor of

this building, creating a fully glazed, kinked storefront all along Lincoln Road. The new structure slips under and opens up the heavy concrete building for 16 tenants who bring new brands to Lincoln Road Mall, from Y3 to Osklen to Taschen to Nespresso, from clothes to books to coffee and so forth. A new entry and an open, lit staircase in one of the existing corner towers of the Suntrust building indicate the new rooftop restaurant, which offers exquisite views over the Art Deco District and the Miami Beach skyline alongside the Atlantic Ocean.
