## ACCESS TO BETICA STREET

Badia del Vallès is made up of diverse blocks of flats from the 1960s that were built in the area occupying the natural terraces of the topography. At the junction between Carrer Bètica and Avinguda de la Mediterrània, there is difference in height of 8.5 m. The existing slope is excessively steep and fails to meet necessary accessibility requirements to guarantee the relationship between citizens living in the lower level and the facilities of Carrer Bètica.

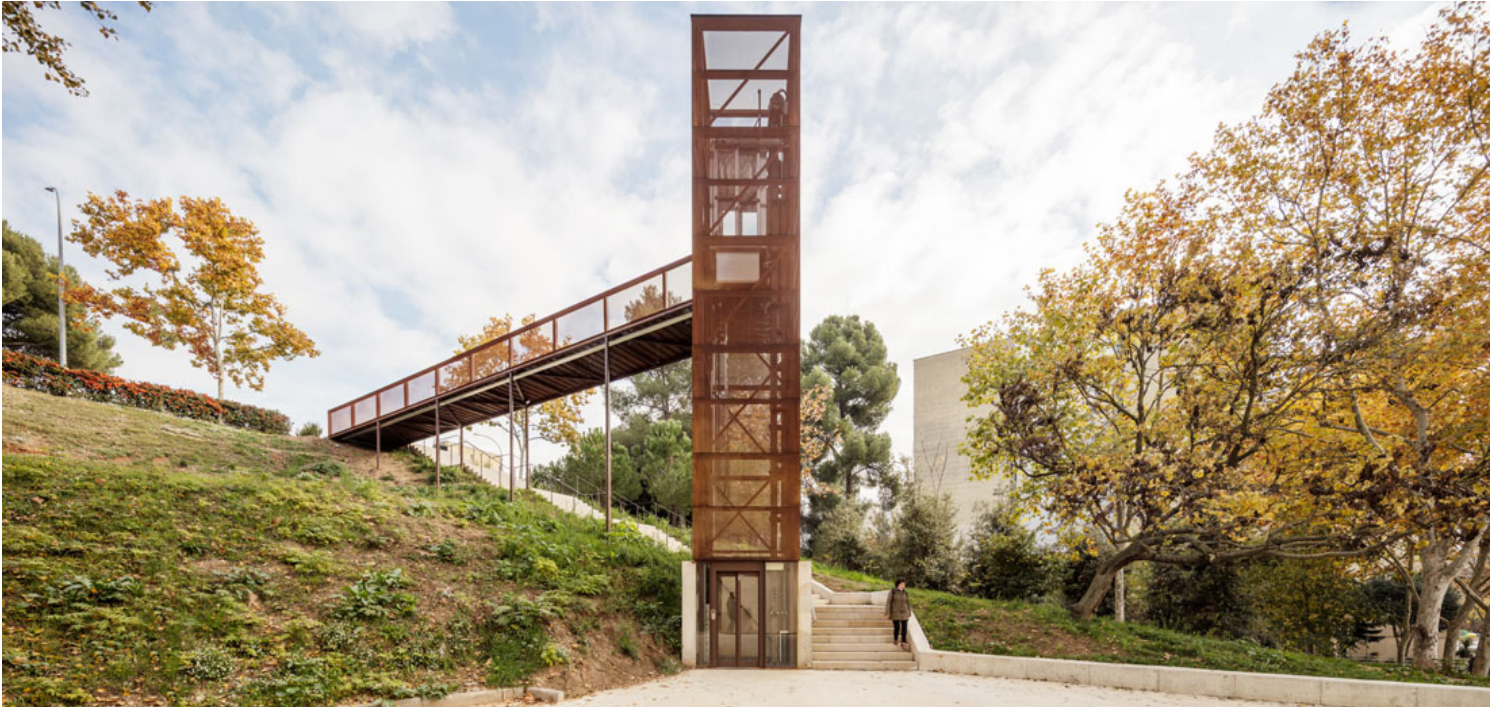
The proposal consists in installing a lift in a strategic point that makes it easier to see and reduces the distances people have to walk. The structure consists of a framework of tubular metal 10-cm profiles and diagonal 5-cm profiles.

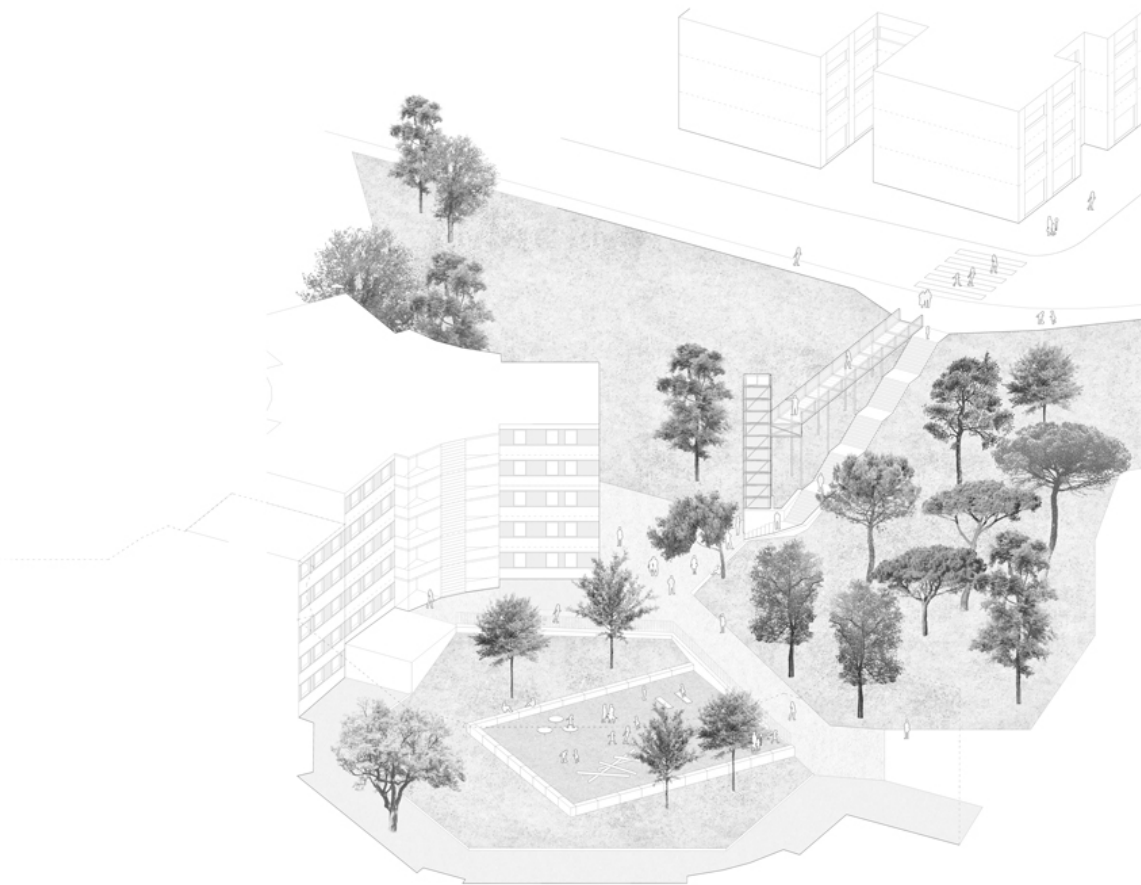
The cage is closed by a sheet of micro perforated Corten steel on three sides, and laminated glass on the eastern face. The intervention also includes a new stairway built at a tangent to the footbridge, and the improvement of the sector's interstitial public space, resolved through geometry and permeable surfaces capable of dealing with water accumulation problems.
