EL MOLÍ LIBRARY

El Moli Library

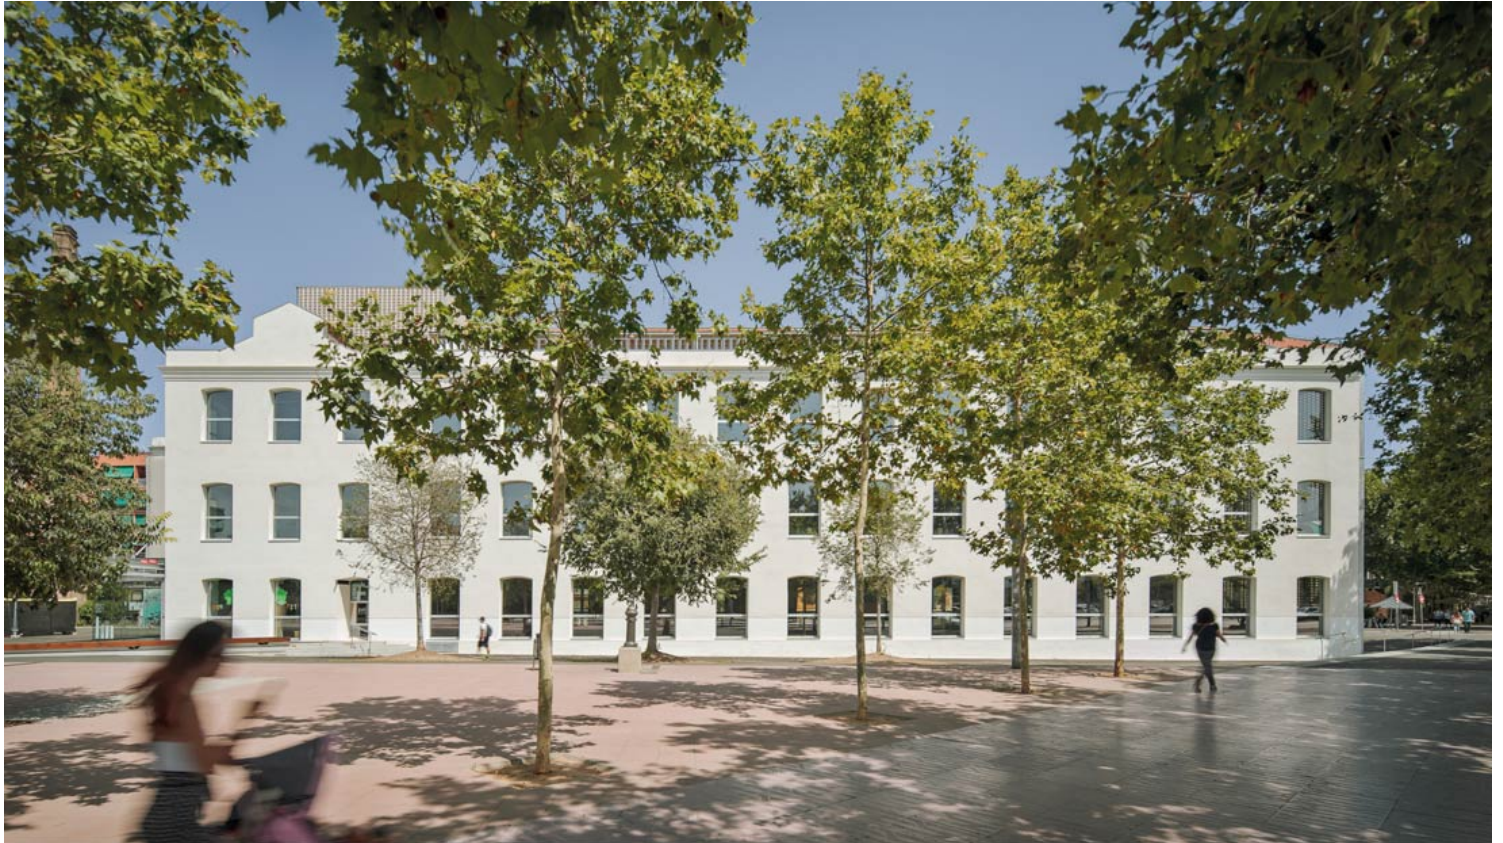
The library is located on the two upper floors of the former Ferrer y Mora textile factory built in 1858. In the future, municipal offices will occupy the rest of the ground and first floors. This multiple-storey location creates a new section of the roof, restore some side terraces and allow for views and natural lighting.

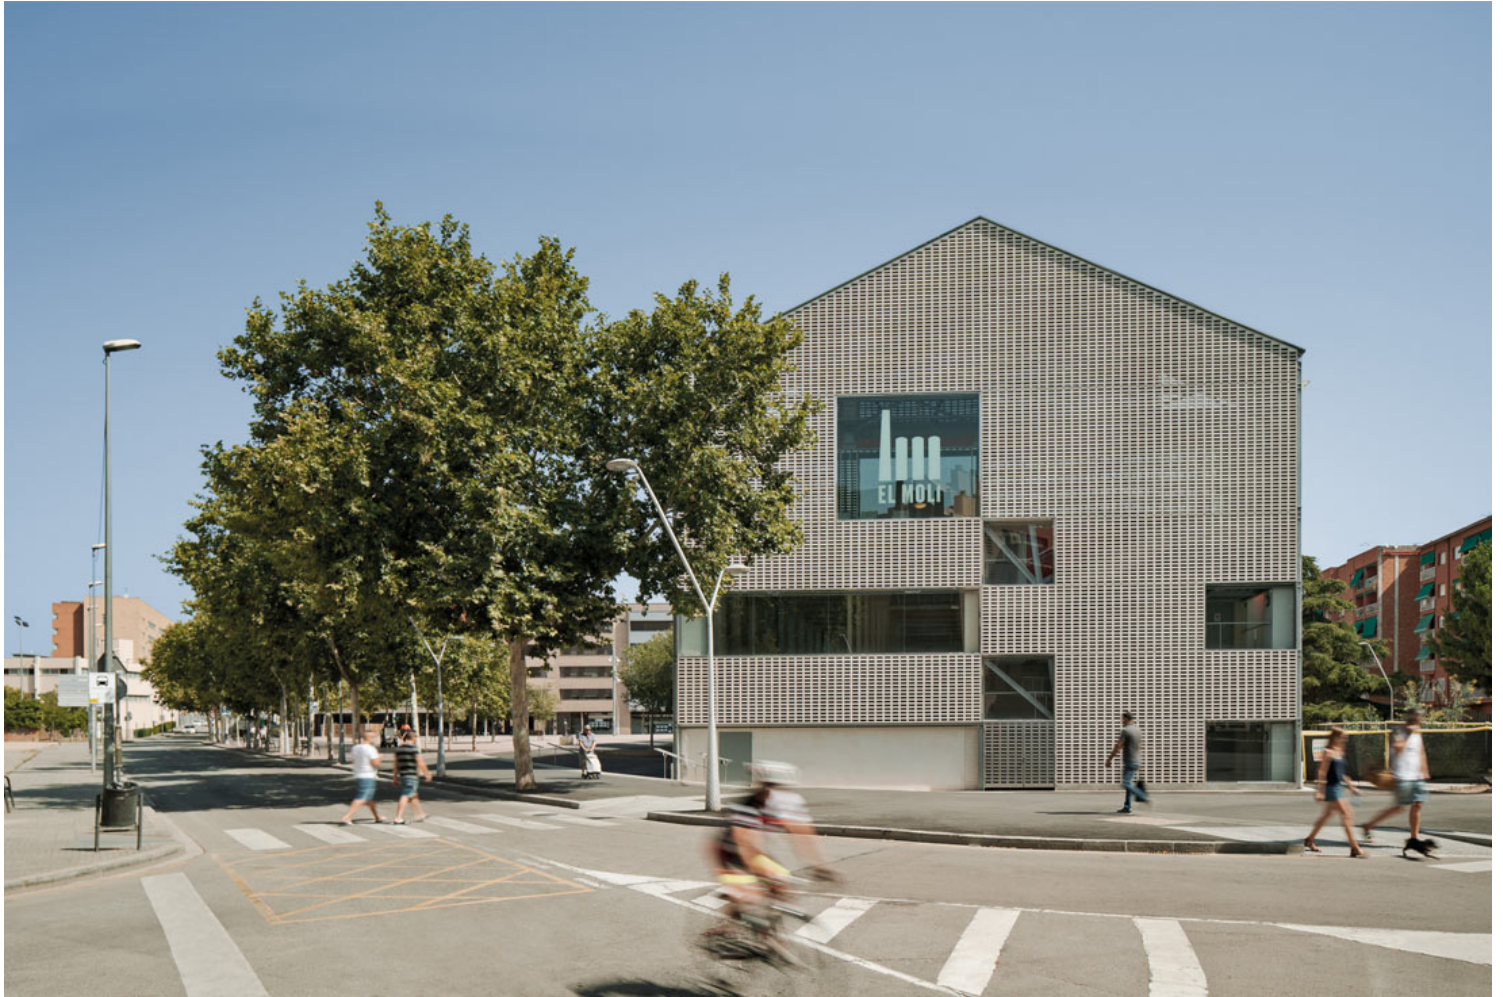
Because El Moli does not follow the orientation of Terraplè boulevard, the building has been left in a unique urban position. The practically windowless south wall has been transformed into a new main façade, a gallery that allows the light to flow inside, filtered by a ceramic lattice wall.

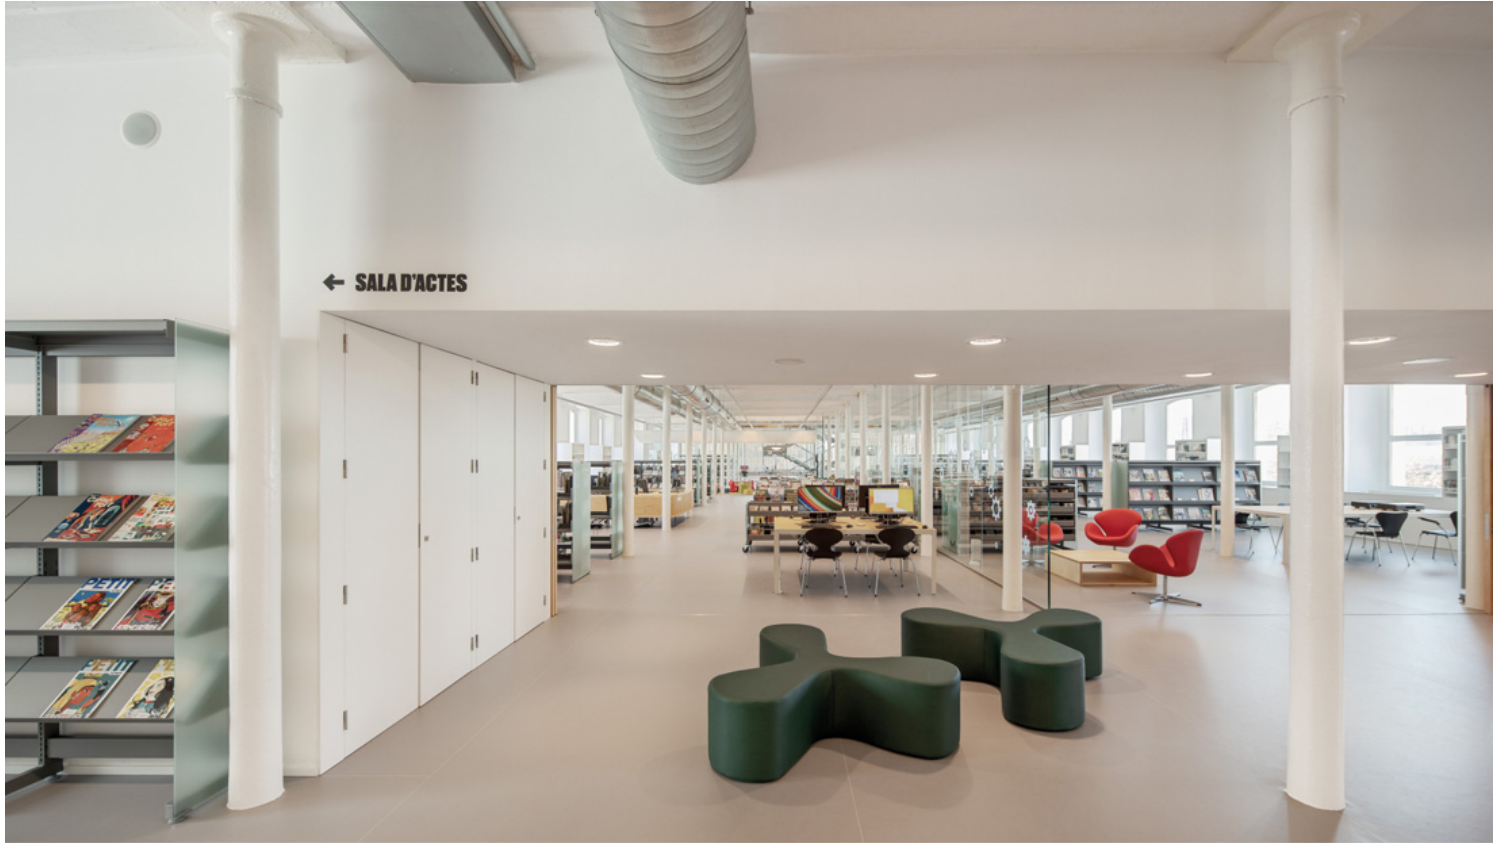
The vertical communications core and the installation ducts are located in the centre of the building. This new space, which has a system of crossed walkways around a staircase suspended from the roof, provides an immediate understanding of the building through the visual relationships and transparencies between the different levels. The marks and textures of the past engraved in the walls and the irregularities where pulleys and belts were anchored were preserved.

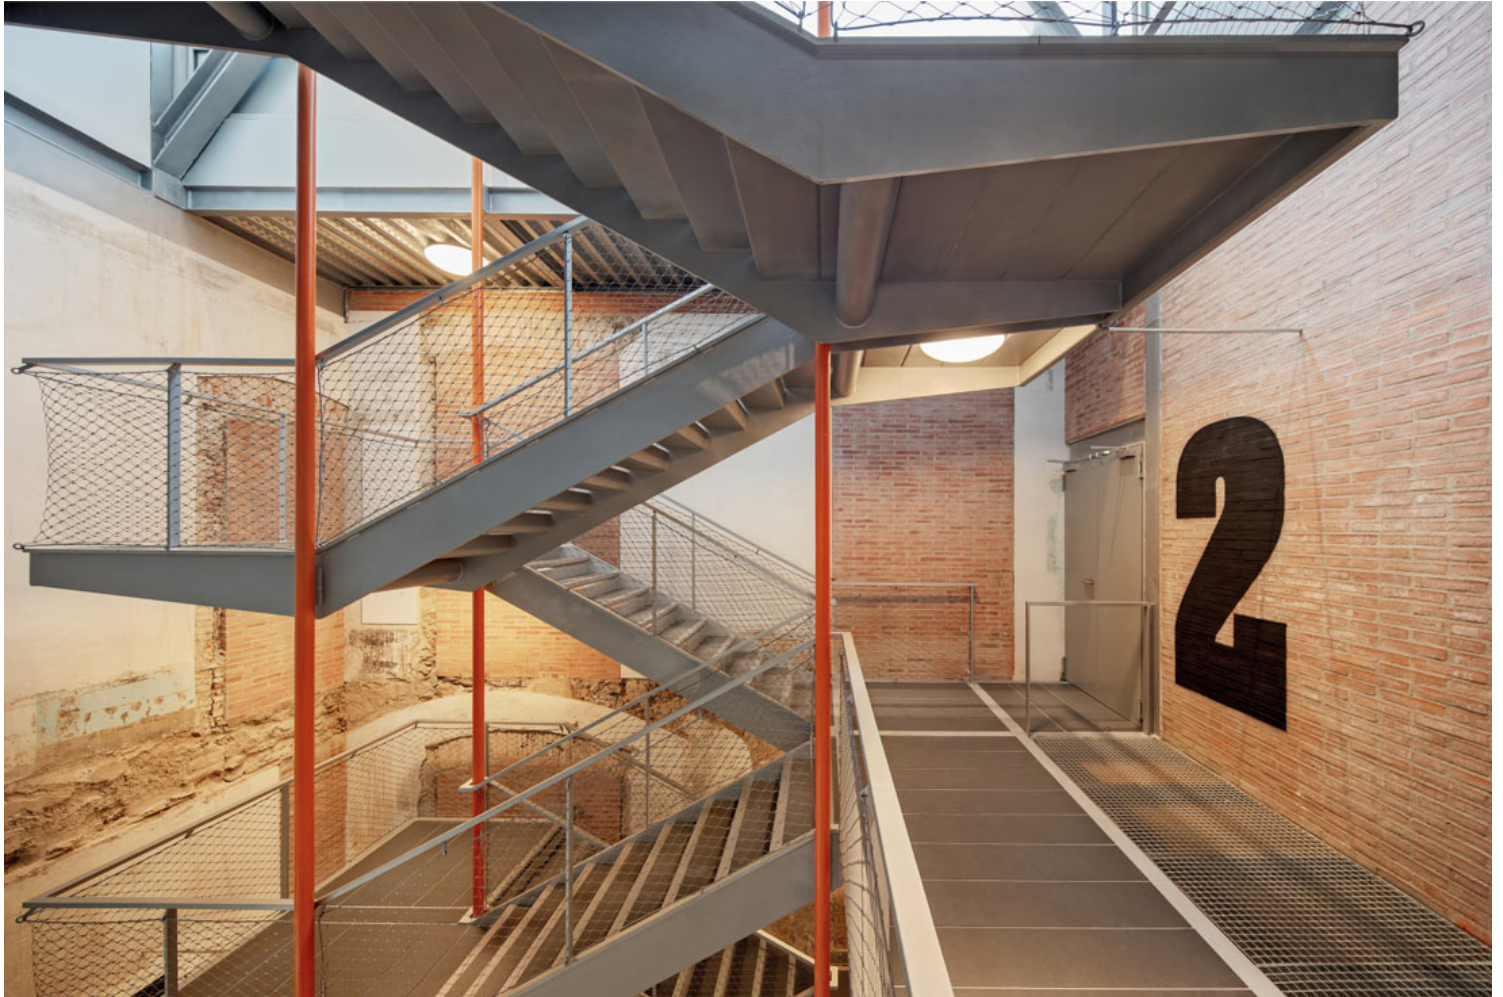
The project focuses on restoring the façade materials and recovering the original interior structure via an upper reinforcement with lightened concrete over the ceramic partitioned vaults supported by wooden beams resting on the existing iron columns.
