## NIÑA DE MAQUILADORA

Niña de Maquiladora

Ciudad Juarez is a Mexican border city that is heavily industrialized due to cross-border trade between the U.S. and Mexico. The factories here are called maquiladoras and they favor female workers over men to perform their intensive labor. The globalization of the area combined with the culture of machismo has created a dangerous environment for the maquiladora women. They have been sexually assaulted, kidnapped and murdered during their commute to work, typically in the downtown area. The existing cultural structure and government institutions are not protecting their wellbeing. A potential way to address the issue could be through a crisis center for women in the downtown area, along with expansions of the bus transportation infrastructure, to create a system of centralized and distributed safe havens.

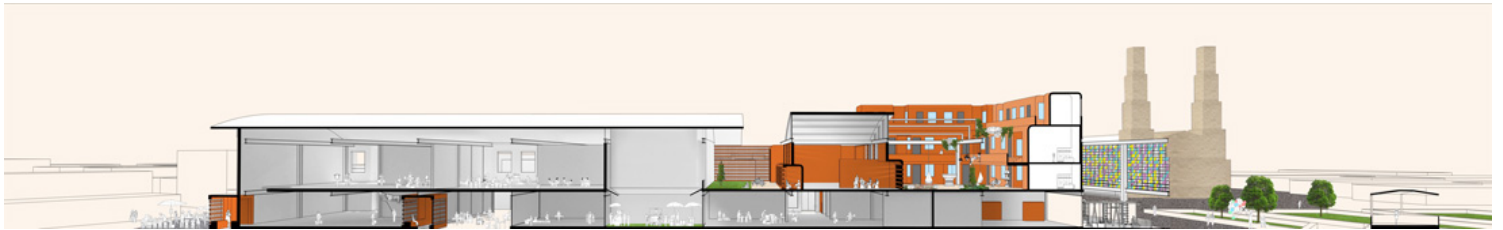
colonias where women live. In response, the centralized crisis center, Casa Reforma, an extension of Casa Amiga, will be sited in the downtown area. The downtown acts as a point of transition between bus lines and connects the two sides of Ciudad Juarez together, as seen in the map of the city. The distributed network of safe havens acts as an extension of the existing bus infrastructure, providing a safe place for women to access throughout the city.

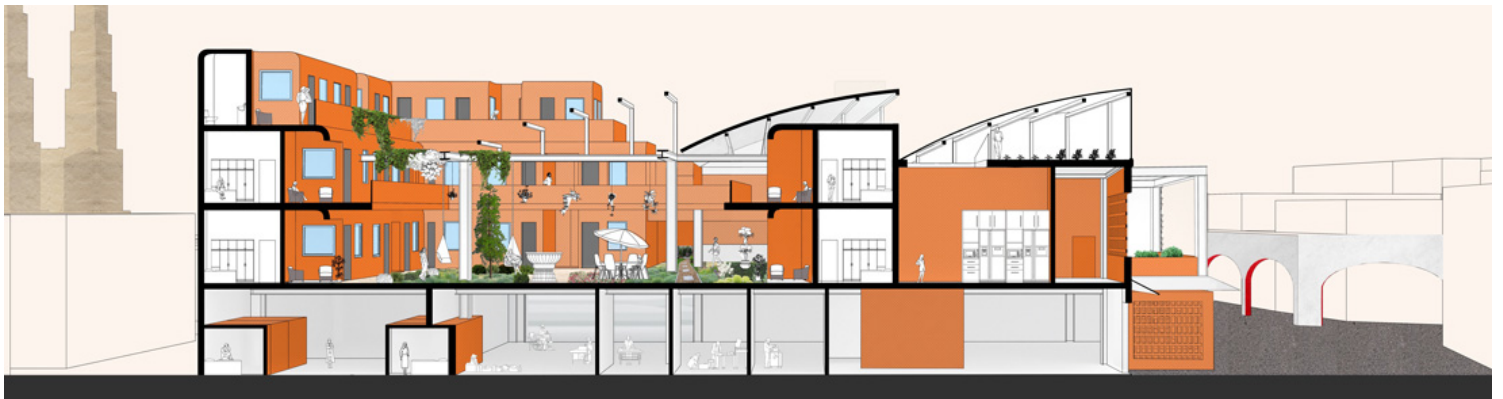
In the heart of the downtown commercial district, the crisis center is incorporated into an existing market building called Mercado Reforma, which is an important building to the community. It is a lively marketplace located in front of a touristic church and a historic park that has been the site of significant protests. A block away is an organization dealing with women's wellness called Instituto Municipal de las Mujeres, whose services could potentially be coordinated ours in the future. The market is on La Paz street, which has a high concentration of nightclubs, bars, and cantinas, where women work late nights after their day shifts at the maquiladora. This thoughtful location will increase the visibility of the crisis center for the women of Ciudad Juarez.

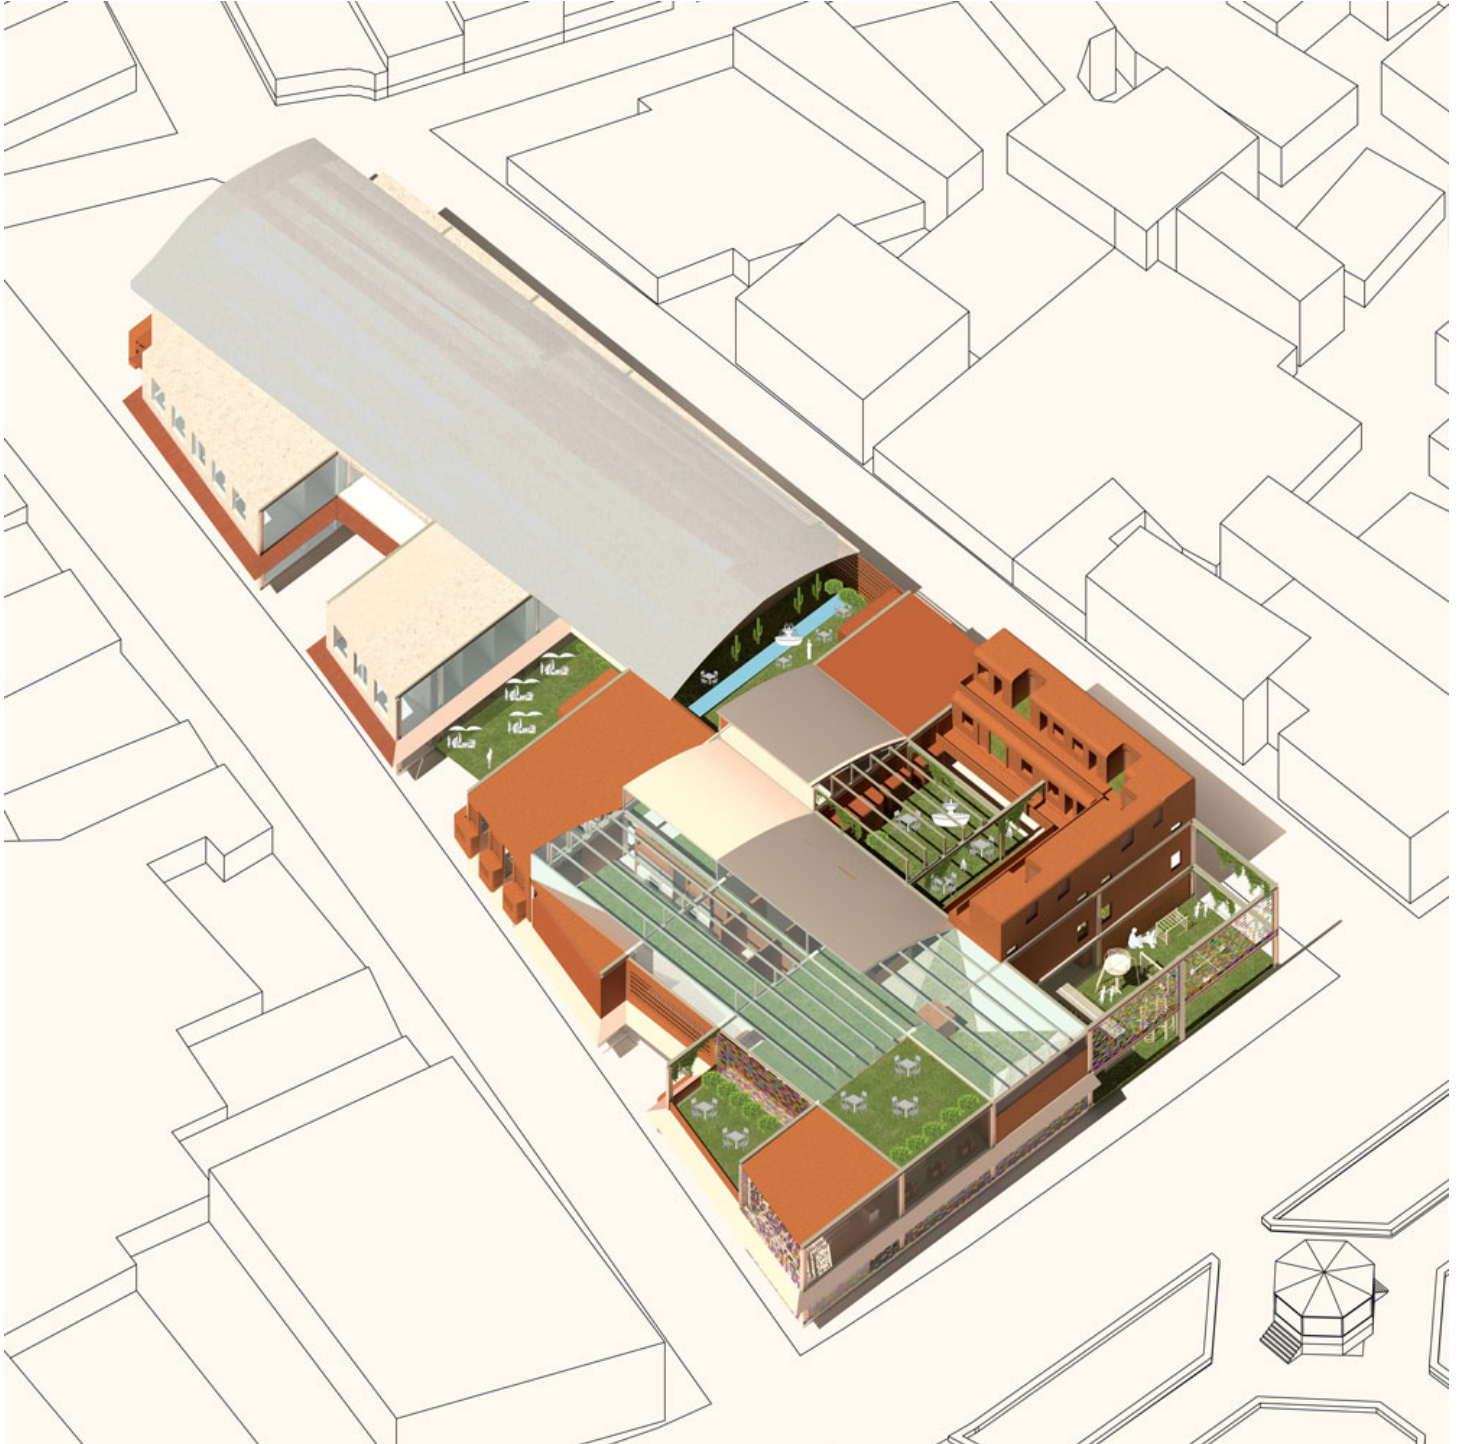
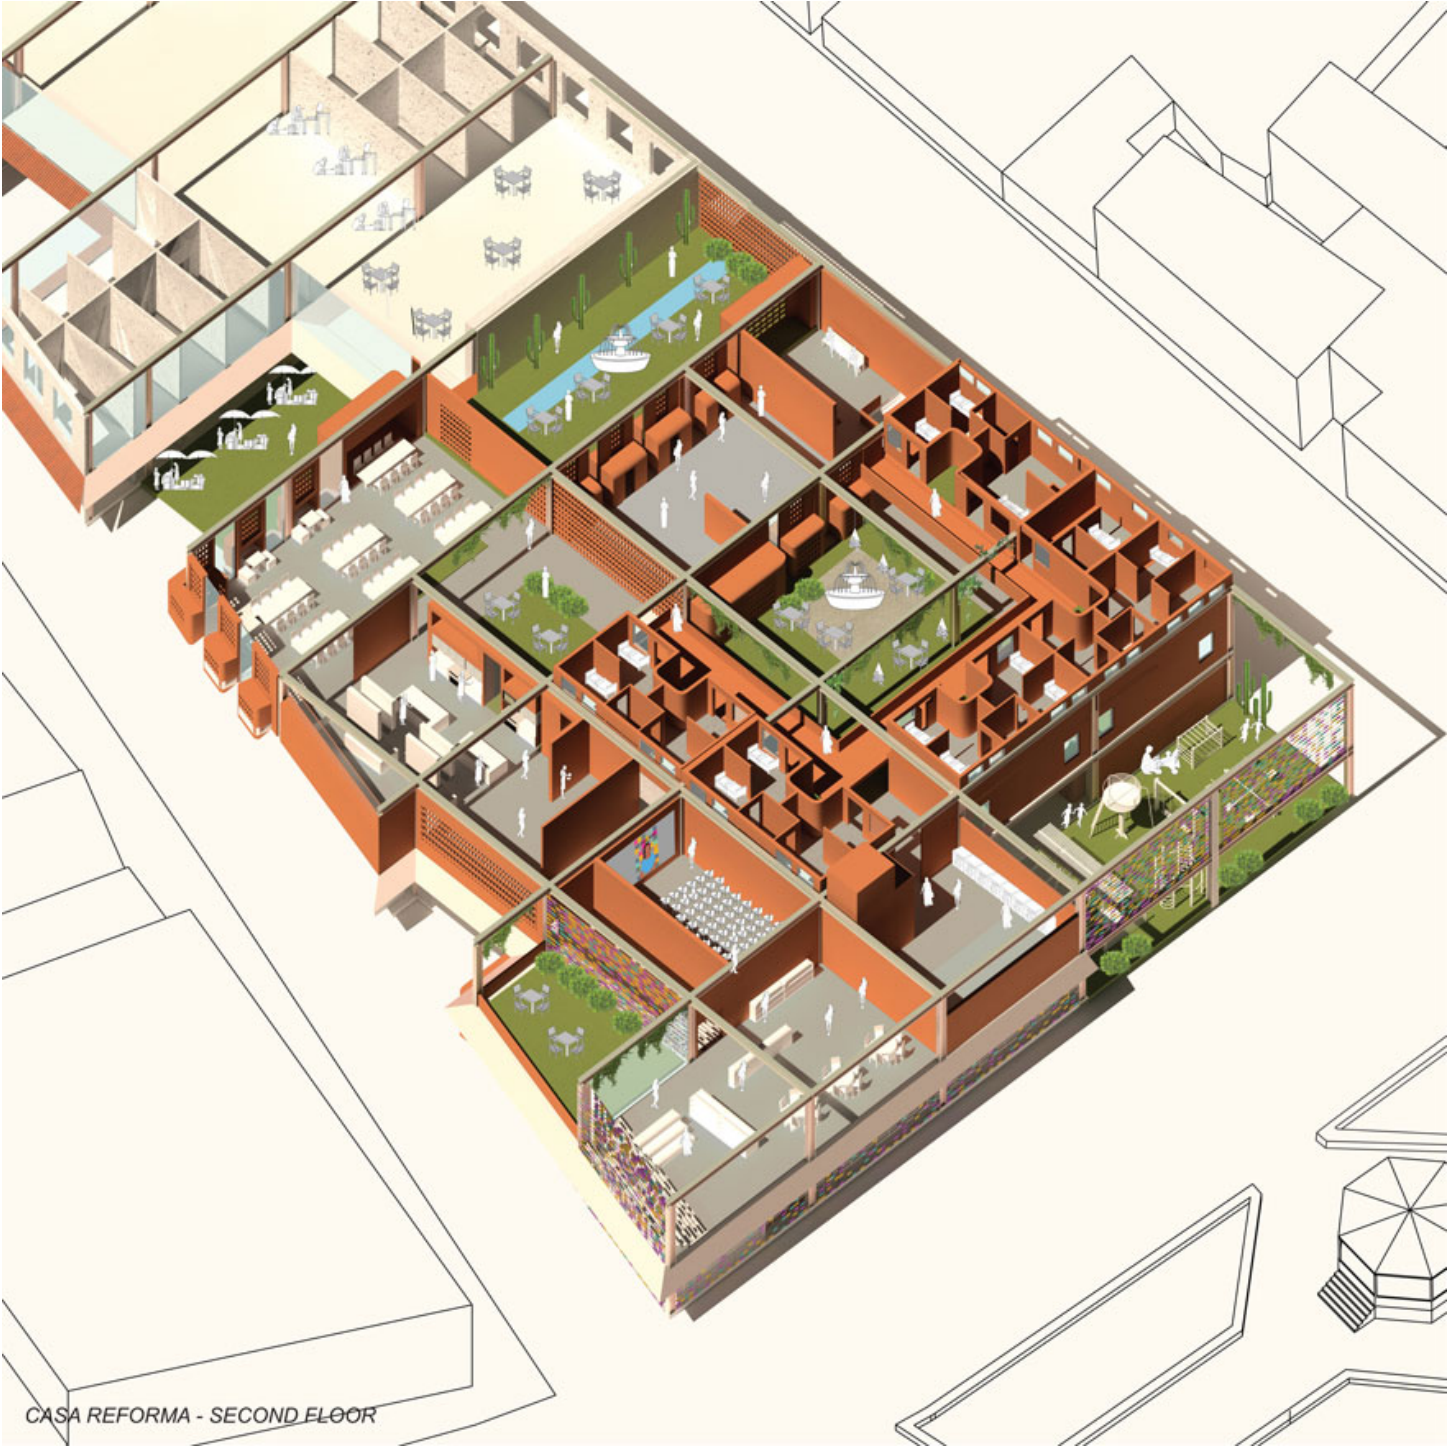
The two main formal strategies are insertion and removal. The insertions are our programmatic elements, which are introduced into the marketplace. Focused on the process of healing, the programmatic insertions are grouped into three categories: private residential, semi-private healing, and community. The layering and sequence begin with women accessing the crowded, public marketplace on the first floor. On the second floor, they reach the community room first, then the

semi-private healing areas through counseling pods, dining pods, and kitchens. Finally, they find themselves in the private residences and their sanctuary-like courtyards. These insertions have been made on the second floor in order to maintain the existing public market quality of the first floor, and to distinguish between intimate and busy spaces. However, on the first floor, there is a network of distributed safe haven pods across the marketplace that women can access in case of emergency.

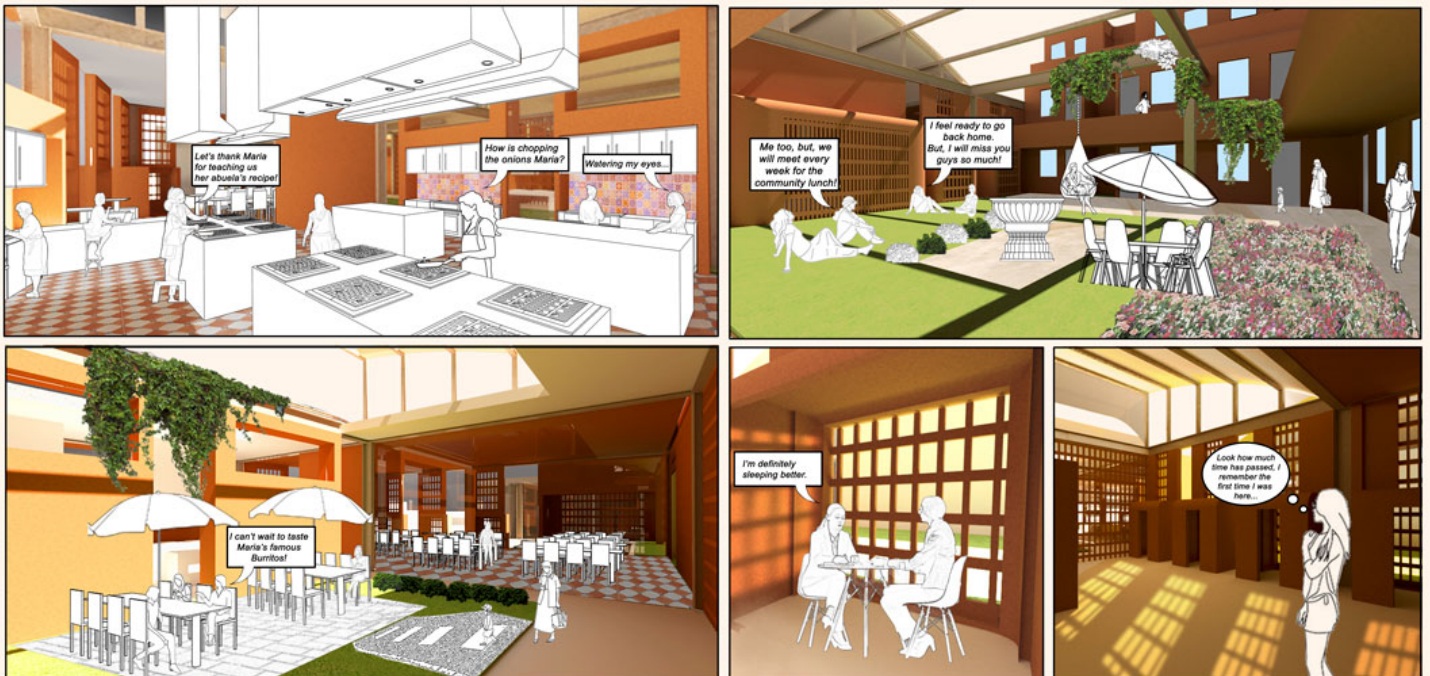
The removals are associated with different purposes, creating outdoor spaces used either for the existing market's commercial activity or for our program. The removal in the middle of Noche Triste is specifically for the women in the community to sell the ceramics they make in the crisis center. This removal creates an arcade that connects the two sides of the building through an outdoor commercial space. It also activates the opposite street, which is less busy than Noche Triste. On the main street, Av. Vicente Guerrero, this removal is a playground for children, acting as an extension to our daycare program. The interior removals on the second floor create courtyards that provide spaces for the community with increased light and safety.
