RESTORATION OF TWO SNOW WELLS

This project emerged from the Master Plan for the Snow Wells of the Sierra Espuña, which included the cataloging and analysis of the state of conservation of these ancient ice factories. Thanks to this effort, in November 2022, the cultural landscape of the wells was declared a Cultural Heritage Site (BIC) in the category of "ethnographic place of interest".

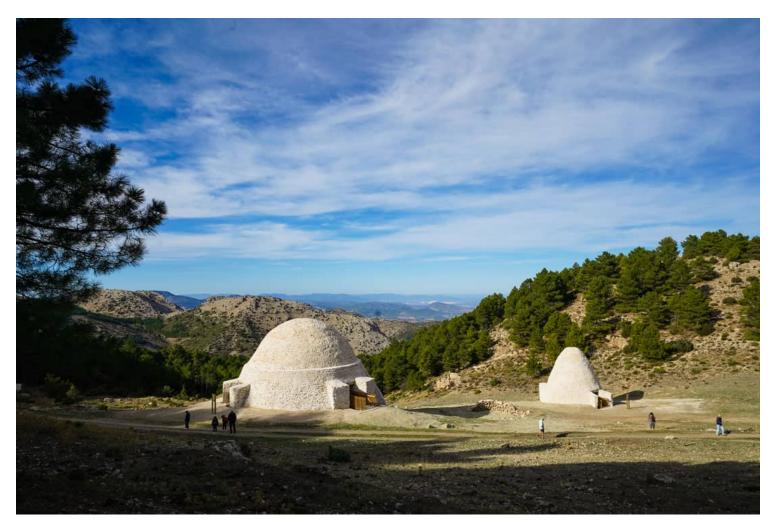
Among the urgent measures outlined in the Master Plan was the restoration of wells number 11 and 13 due to their uniqueness, accessibility, and state of conservation. Despite significant damage and the collapse of a substantial part of their domes, they still retained enough structure and data for their recovery.

Well number 11 stands out as the largest in Sierra Espuña, posing a significant structural challenge. Well number 13 preserved part of its original dome, providing valuable information about its geometry.

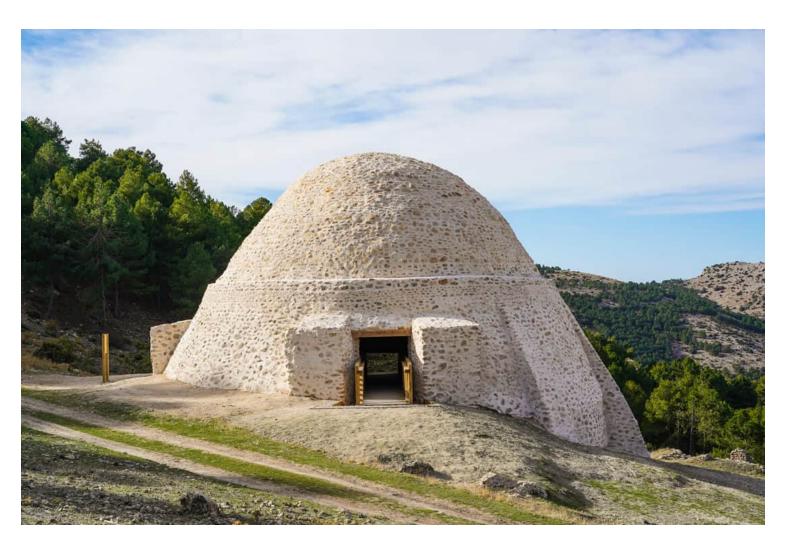
We encountered two distinct typologies: well number 11 had a mixed construction dome (stone/brick), and well number 13 had a stone masonry dome built by layering. This resulted in domes with different shapes: one resembling a hemisphere and the other a cone. We chose to employ these traditional construction systems to preserve the authenticity of the original typologies.

This project centered on the comprehensive restoration of two wells, with the primary goal of recovering their original geometry, resulting in two complete examples from a series of 28 wells. The restoration was carried out using traditional construction techniques and materials: namely, stone and brick masonry, accompanied by lime mortar. Before this intervention, there were no complete wells remaining in the Sierra Espuña that displayed the original structure; two previous restorations had used metal structures, diverging from traditional techniques.

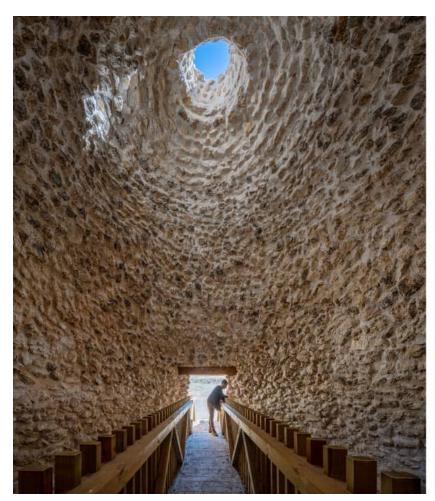
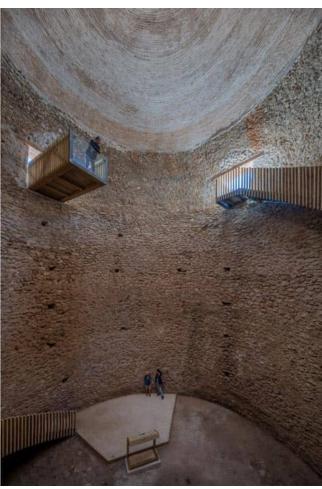
Our ultimate goal was not to restore the original use of these ice factories, which is no longer relevant today. Instead, we aimed to enable visitors to explore these unique structures and learn about the history of the ice trade in the past. To enhance the visitor experience, new access elements were added, such as an observation deck and a staircase in well 11, as well as a walkway crossing the void in well 13. These elements, designed and built in wood, stand out from the original materials.
