## RESTORATION OF TWO SNOW WELLS

This project emerged from the Master Plan for the Snow Wells of the Sierra Espuña, which included the cataloging and analysis of the state of conservation of these ancient ice factories. Thanks to this effort, in November 2022, the cultural landscape of the wells was declared a Cultural Heritage Site (BIC) in the category of "ethnographic place of interest".

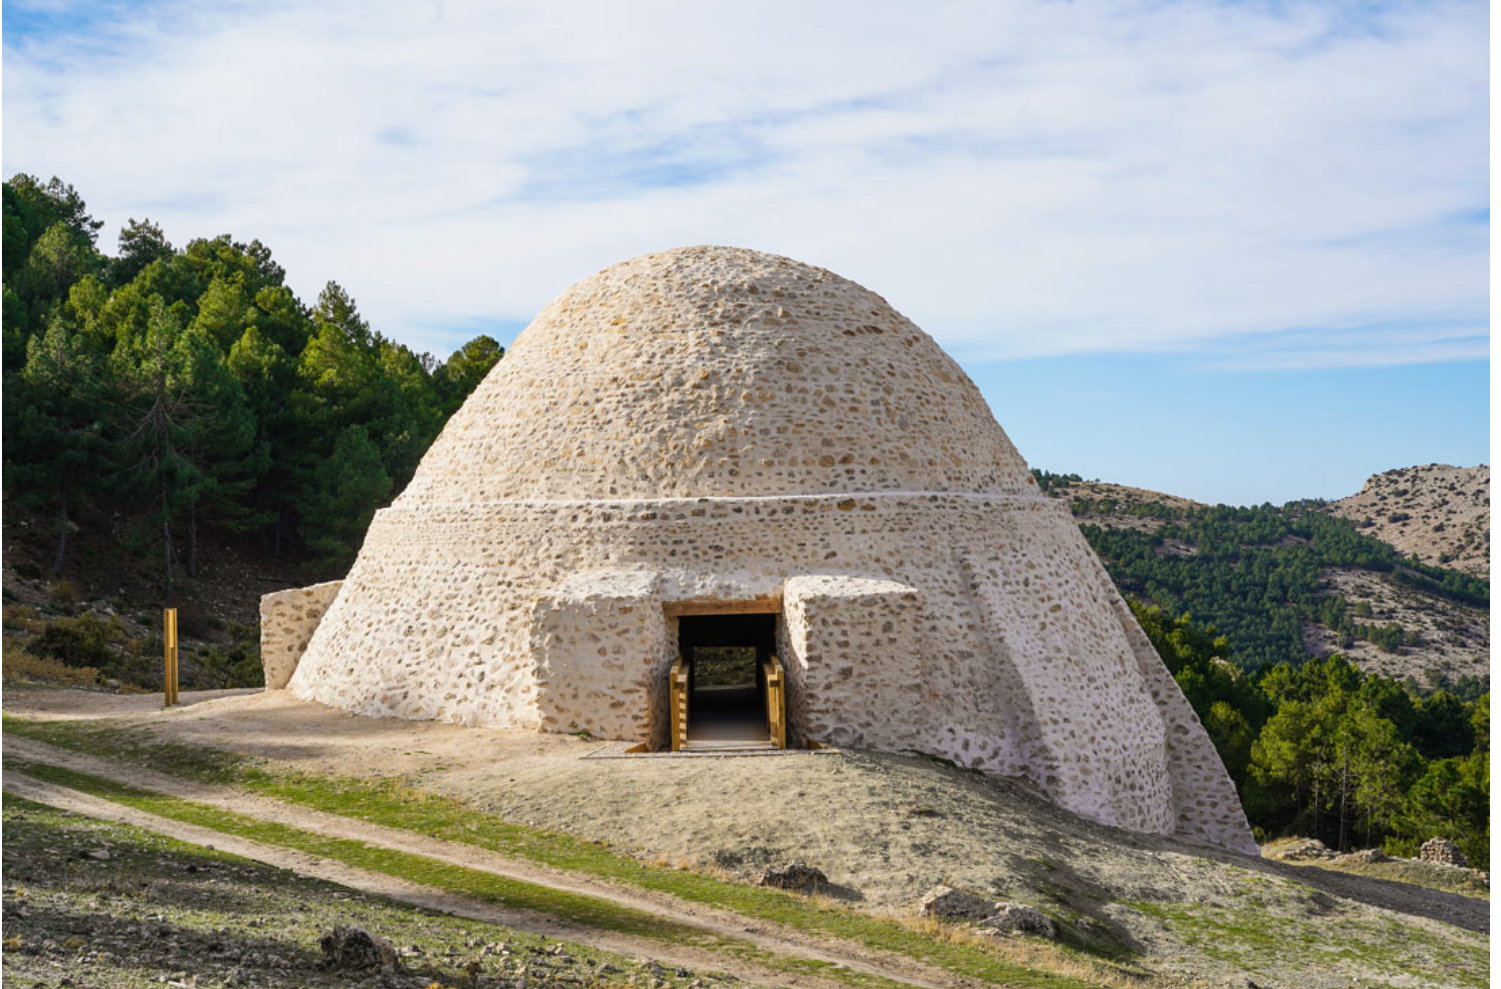
We encountered two distinct typologies: well number 11 had a mixed construction dome (stone/brick), and well number 13 had a stone masonry dome built by layering. This resulted in domes with different shapes: one resembling a hemisphere and the other a cone. We chose to employ these traditional construction systems to preserve the authenticity of the original typologies.

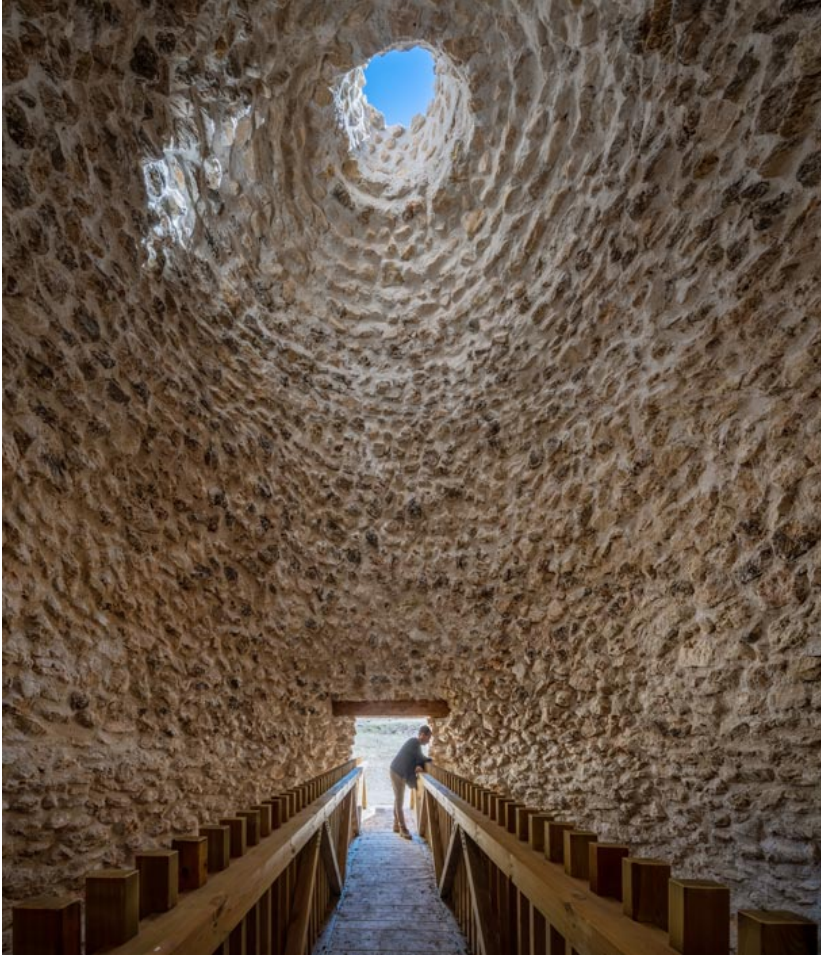
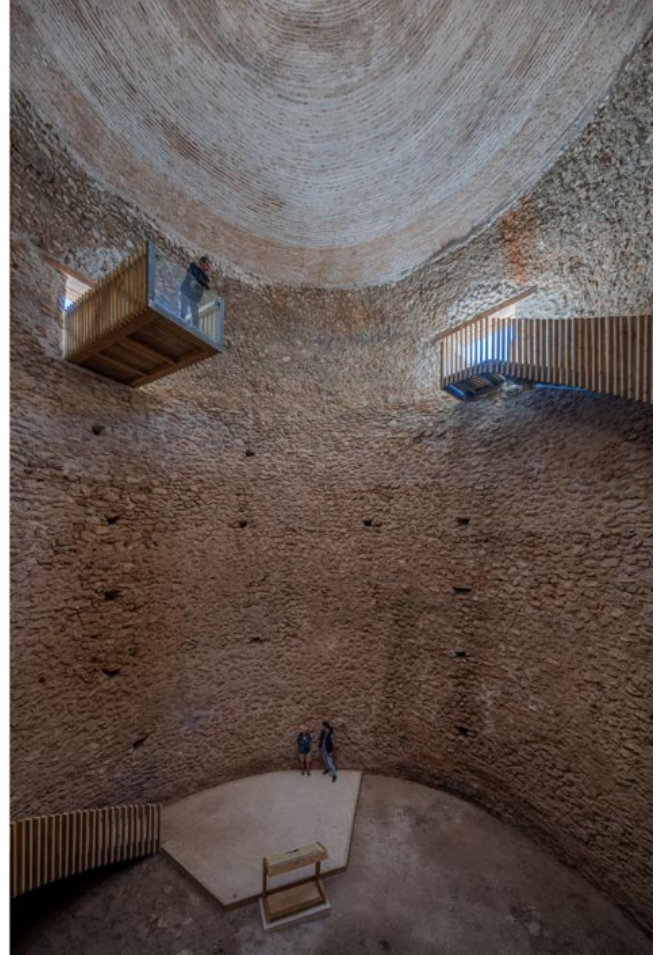
Our ultimate goal was not to restore the original use of these ice factories, which is no longer relevant today. Instead, we aimed to enable visitors to explore these unique structures and learn about the history of the ice trade in the past. To enhance the visitor experience, new access elements were added, such as an observation deck and a staircase in well 11, as well as a walkway crossing the void in well 13. These elements, designed and built in wood, stand out from the original materials.
