Taller de Arquitectura
San Pablo Academic
and Cultural Center

SAN PABLO ACADEMIC AND CULTURAL CENTER: RECUPERATION OF A FORMER CONVENT

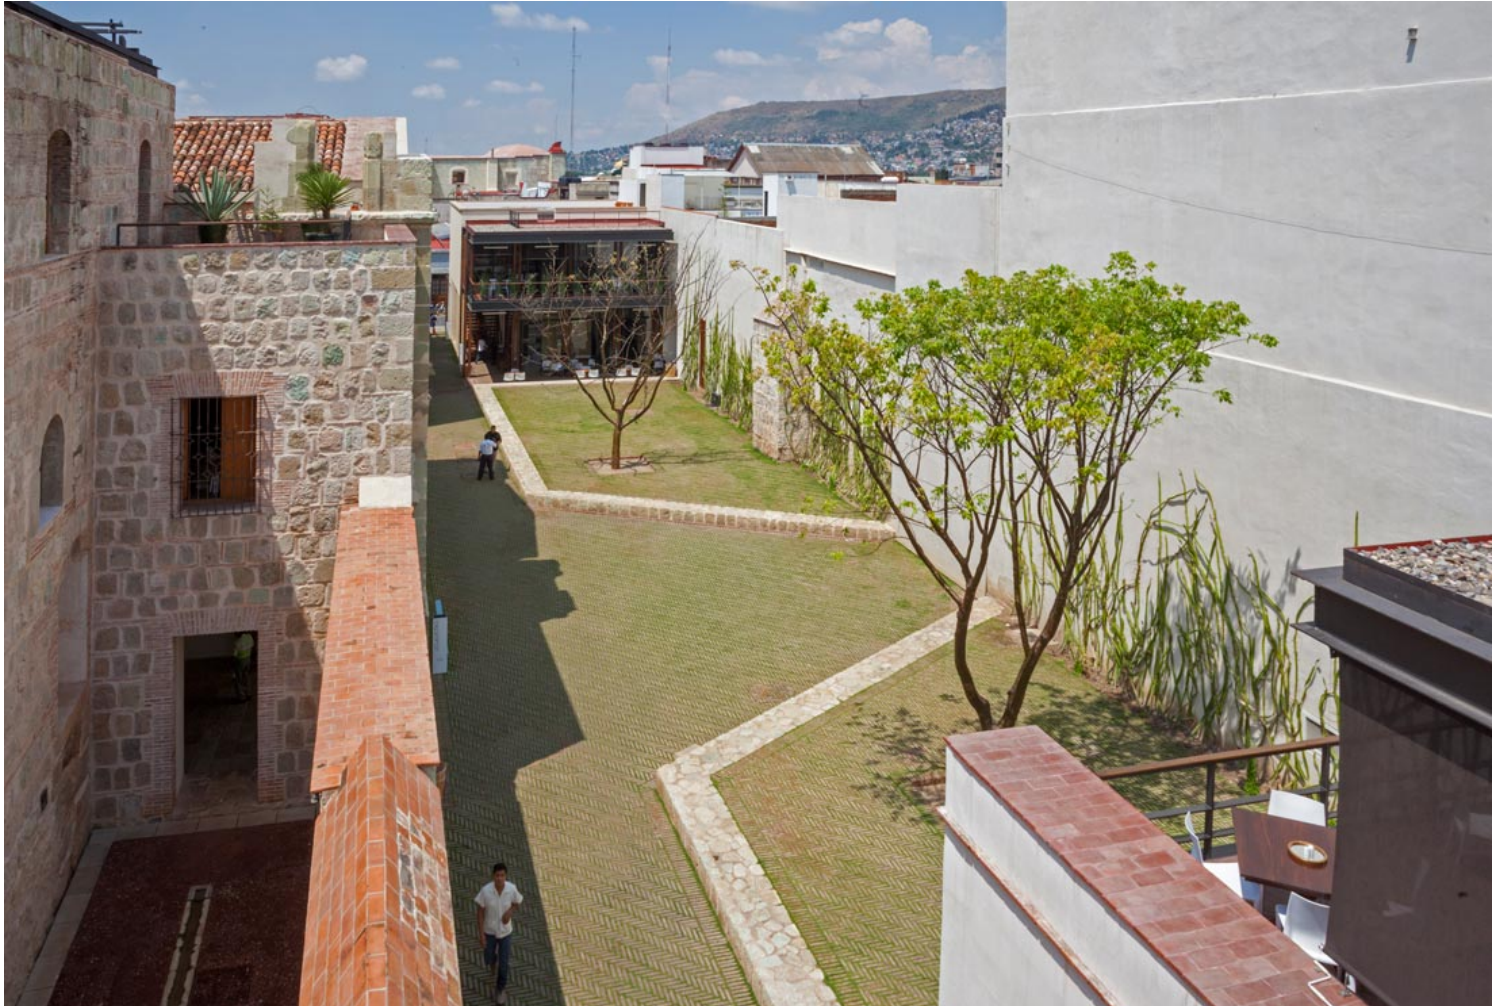
Along with the east ambulatory, this contemporary element creates useful areas with a surface of almost 700 square meters. Divided into three levels, it satisfies the area requirements for the operation of the Linguistic and Historic Studies and Exhibition Center, which houses the specialized book collection along with cultural and exhibition activities, with a stable climate and protected from the elements.
