WATER TOWER

Water Tower

On February 27, 2012 Chile suffered the second most severe earthquake in its history. It measured 8.8 on the Richter scale and was followed by a tsunami that razed 700 kilometers of the coast—as well as Robinson Crusoe island, 350 miles west of the epicenter. As well as the loss of life, a lot of the country's infrastructure suffered damage, such as the 17 large water towers that collapsed and many others that were damaged.

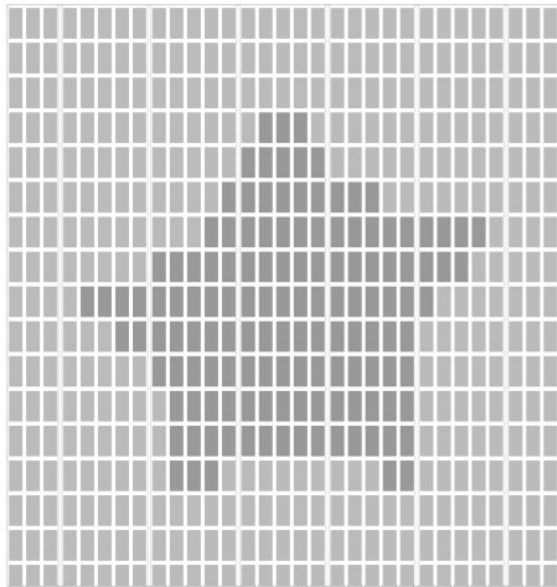
ESQUEMA ESTRELLA ESC. 1/30

Aluminio medio 45% brillo
cod. 7257 HD

Aluminio opaco 15% brillo
cod. 3083 HD

CODIGO COLORES

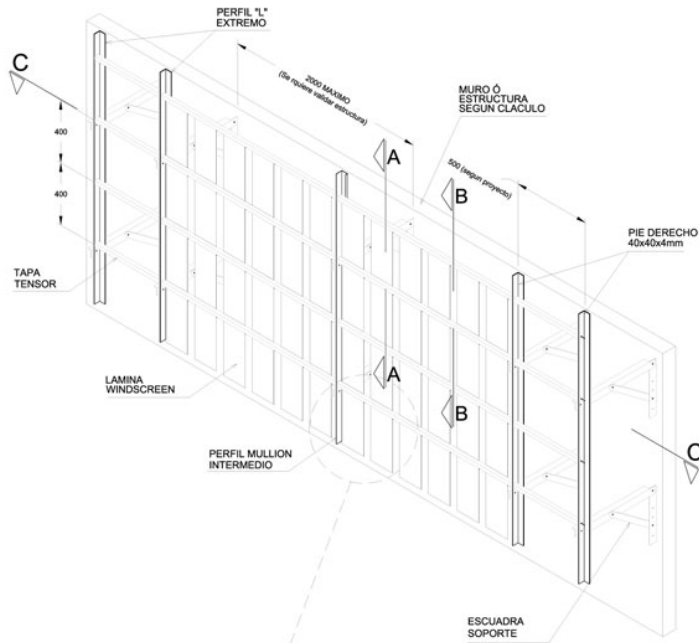
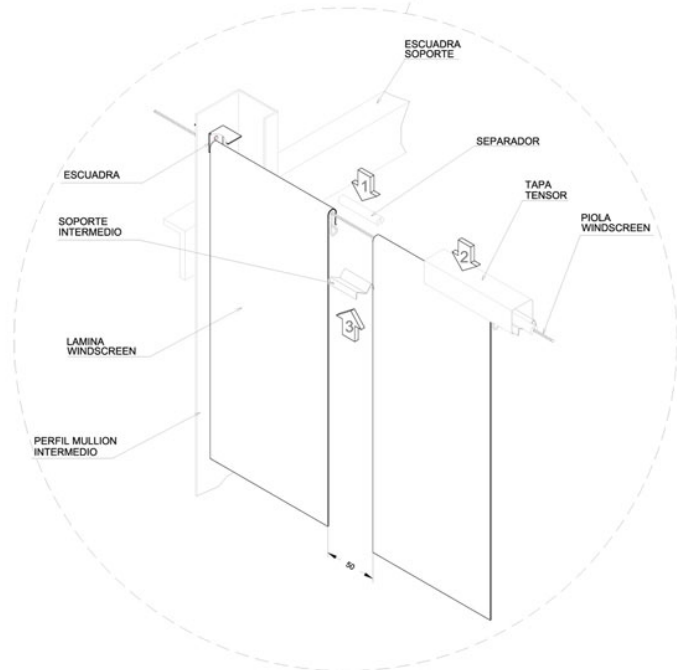
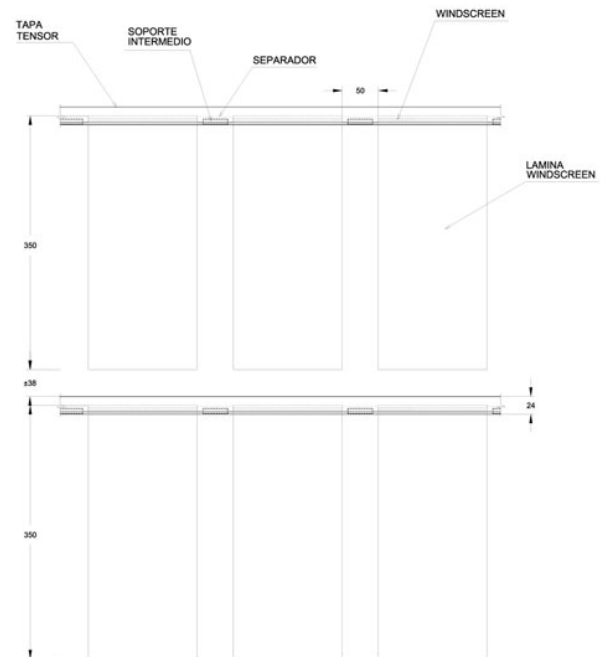
Details

Sistema Windscreen De Hunter Douglas

Meanwhile, the Rancagua water tower represents an improvement to the appearance of an existing structure. In this city, 90 kilometers to the south of Santiago, a competition had been held for sculptors to propose interventions in the structure. The winner had designed a series of large spikes that transformed the water tower into a kind of huge porcupine. The problem was that in the wake of the earthquake this was considered too dangerous a proposal, and we were asked to put forward an alternative. The idea was to create a surface that reacts to the wind in a manner resembling water.
