## WATER TOWER

*Posted on December 8, 2016 by Urban UrbanNext*

Water Tower

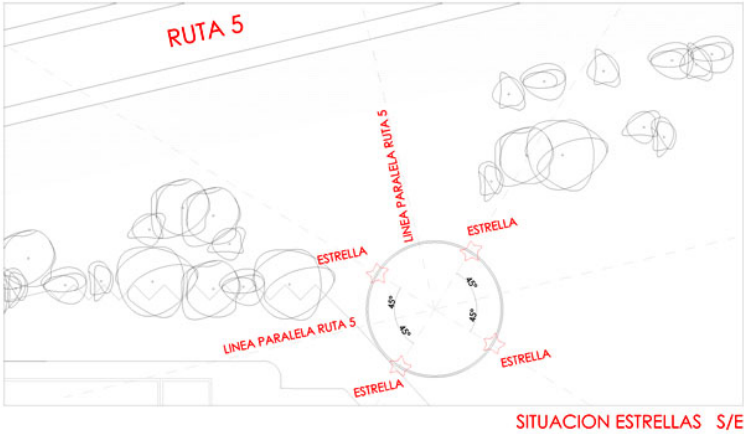
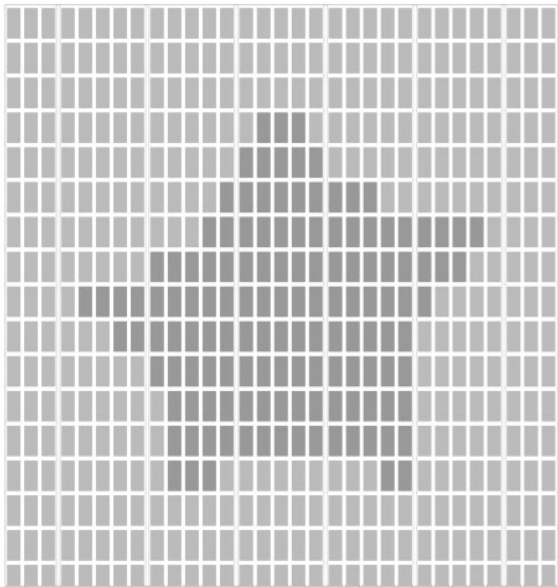
ESQUEMA ESTRELLA ESC. 1/30

Aluminio medio	45% brillo cod. 7257 HD

Aluminio opaco	15% brillo cod. 3083 HD

CODIGO COLORES

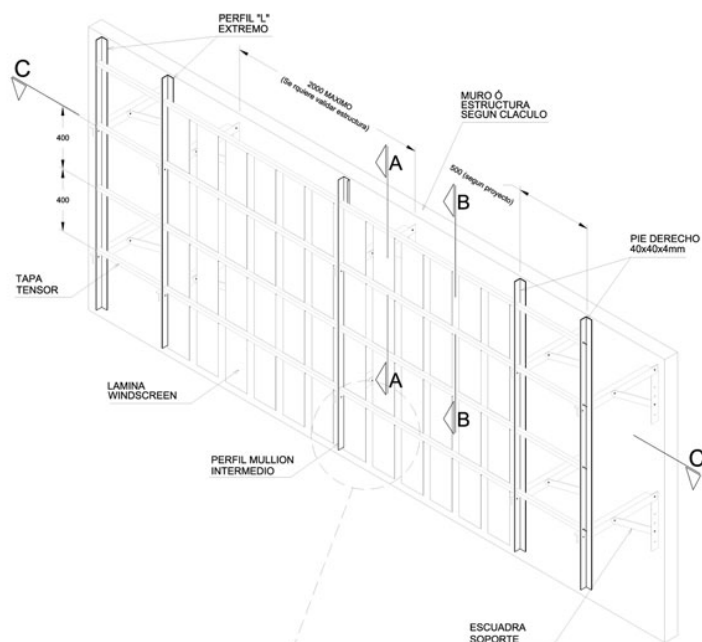
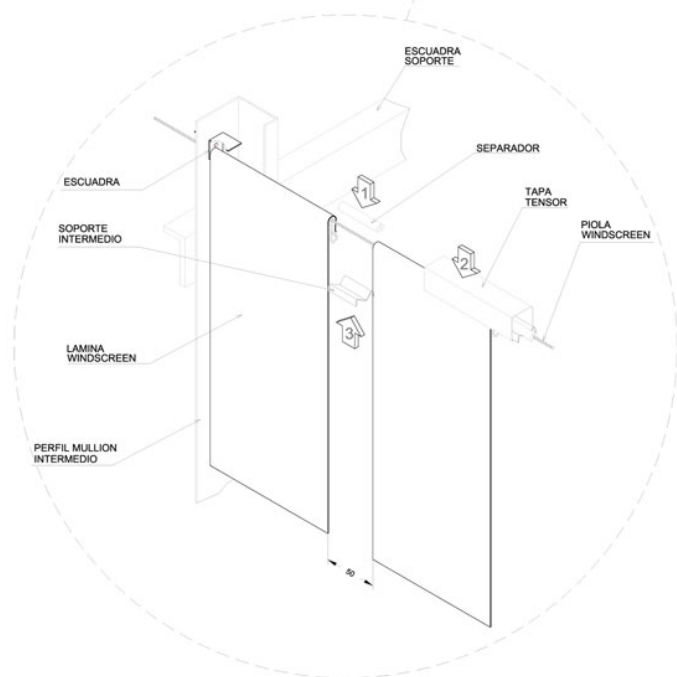
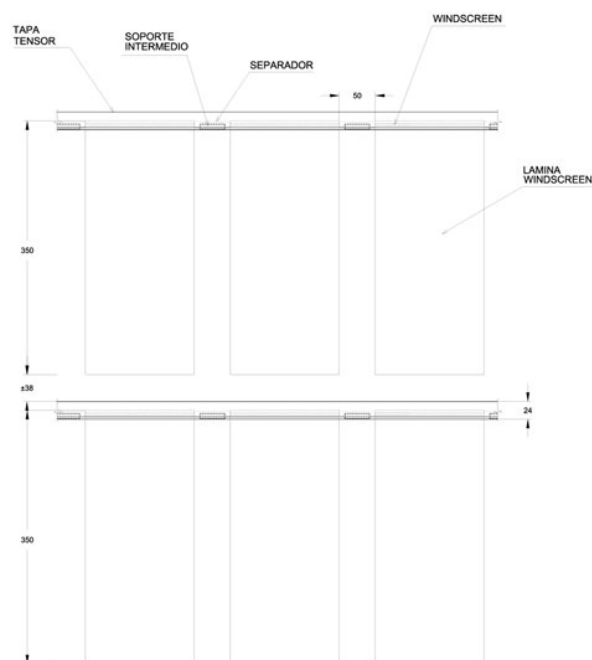
## Details

## Sistema Windscreen De Hunter Douglas

Meanwhile, the Rancagua water tower represents an improvement to the appearance of an existing structure. In this city, 90 kilometers to the south of Santiago, a competition had been held for sculptors to propose interventions in the structure. The winner had designed a series of large spikes that transformed the water tower into a kind of huge porcupine. The problem was that in the wake of the earthquake this was considered too dangerous a proposal, and we were asked to put forward an alternative. The idea was to create a surface that reacts to the wind in a manner resembling water.
