WATER TOWER

On February 27, 2012 Chile suffered the second most severe earthquake in its history. It measured 8.8 on the Richter scale and was followed by a tsunami that razed 700 kilometers of the coast—as well as Robinson Crusoe island, 350 miles west of the epicenter. As well as the loss of life, a lot of the country's infrastructure suffered damage, such as the 17 large water towers that collapsed and many others that were damaged.

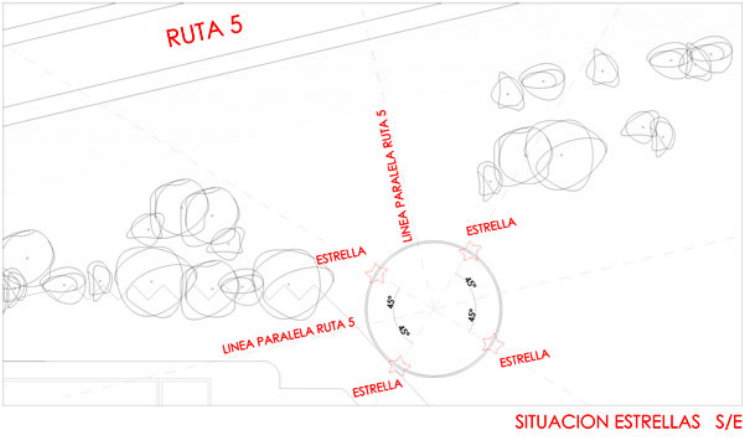
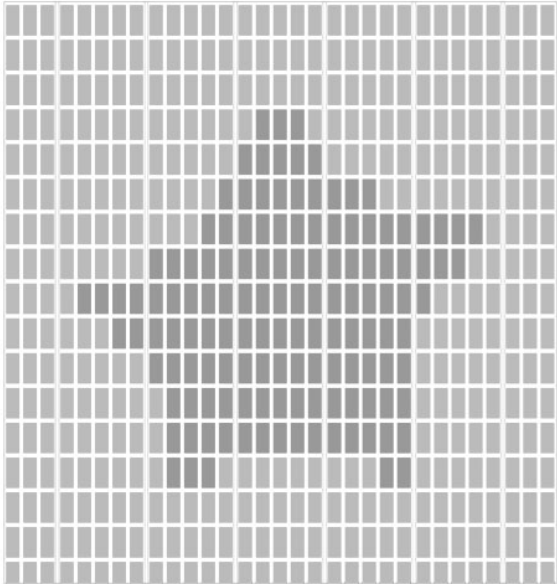
CODIGO COLORES

Aluminio medio	45% brillo cod. 7257 HD

Aluminio opaco	15% brillo cod. 3083 HD

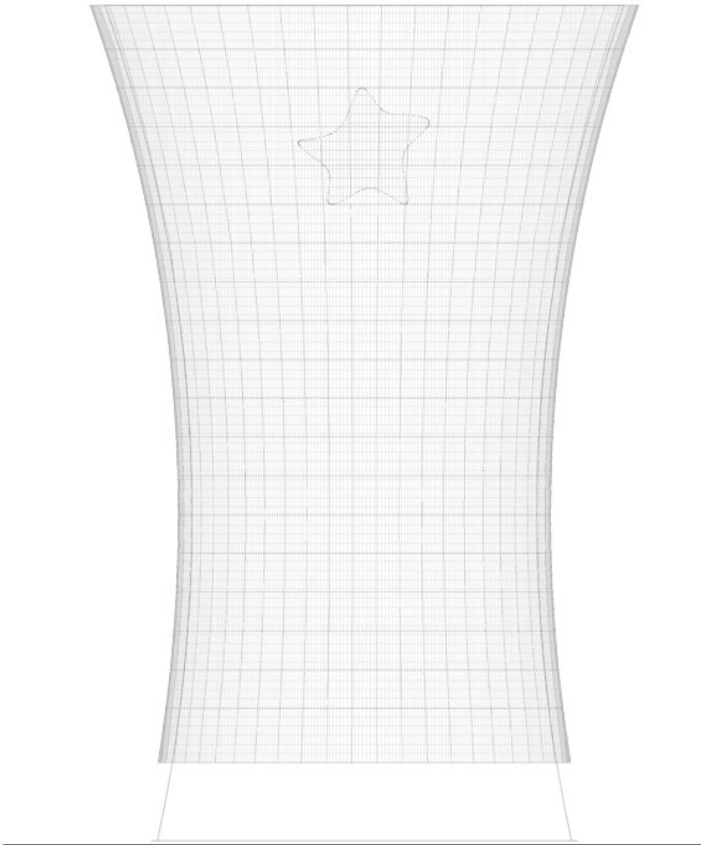
Drawings

Sistema Windscreen De Hunter Douglas
